Transmission Division

Method for repairing OPGW in proximity to energized conductors

The objective of this work is to present a procedure for the repair of a damaged OPGW conductor, in the proximity of energized transmission lines of 138 kV or higher.

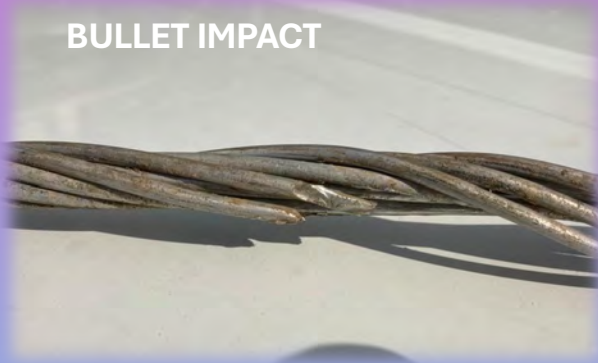
BULLET IMPACT

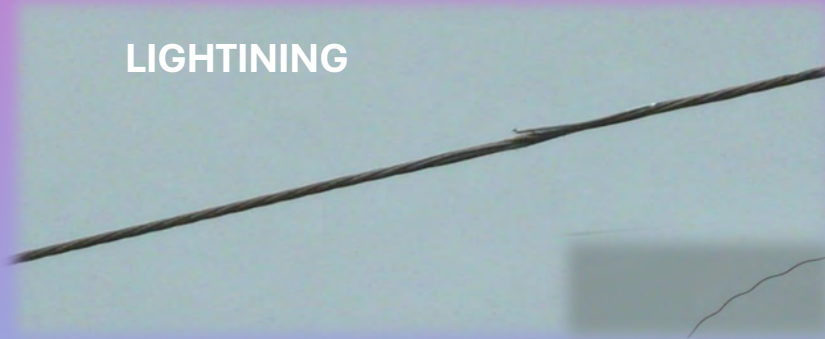
LIGHTNING

The damage of OPGW in Costa Rica by lightning is very common in Costa Rica, because the most of the lines have an OPGW with a low fault current, so they were installed before the newest technical requirements.

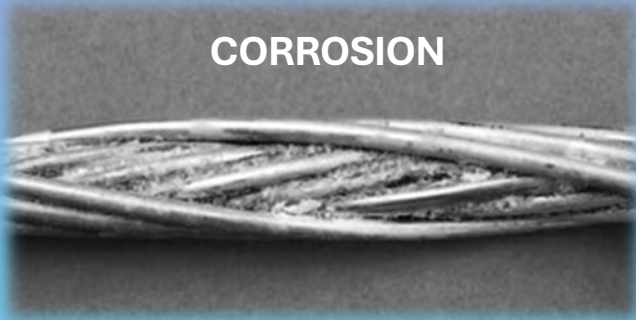
CORROSION

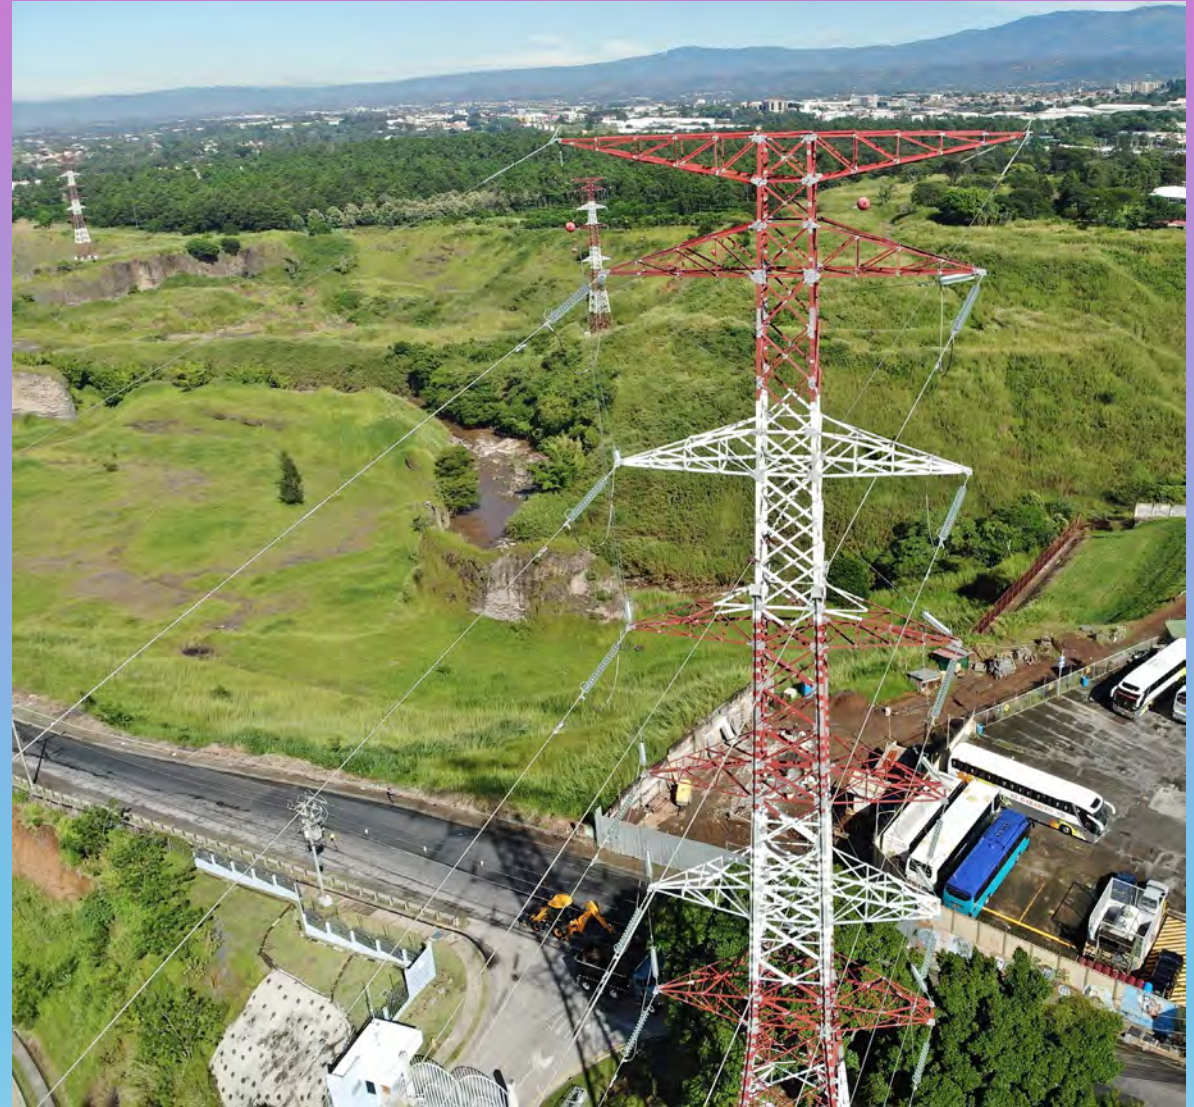
OPGW REPAIR, 31-32

LT SAN MIGUEL-LINDORA
138 / 230KV

- Electric circuits:
 - 2 138 kV
 - 2 230 kV

- Ground wires: 2 OPGW wires

- Span length: 960 ft (320 m)

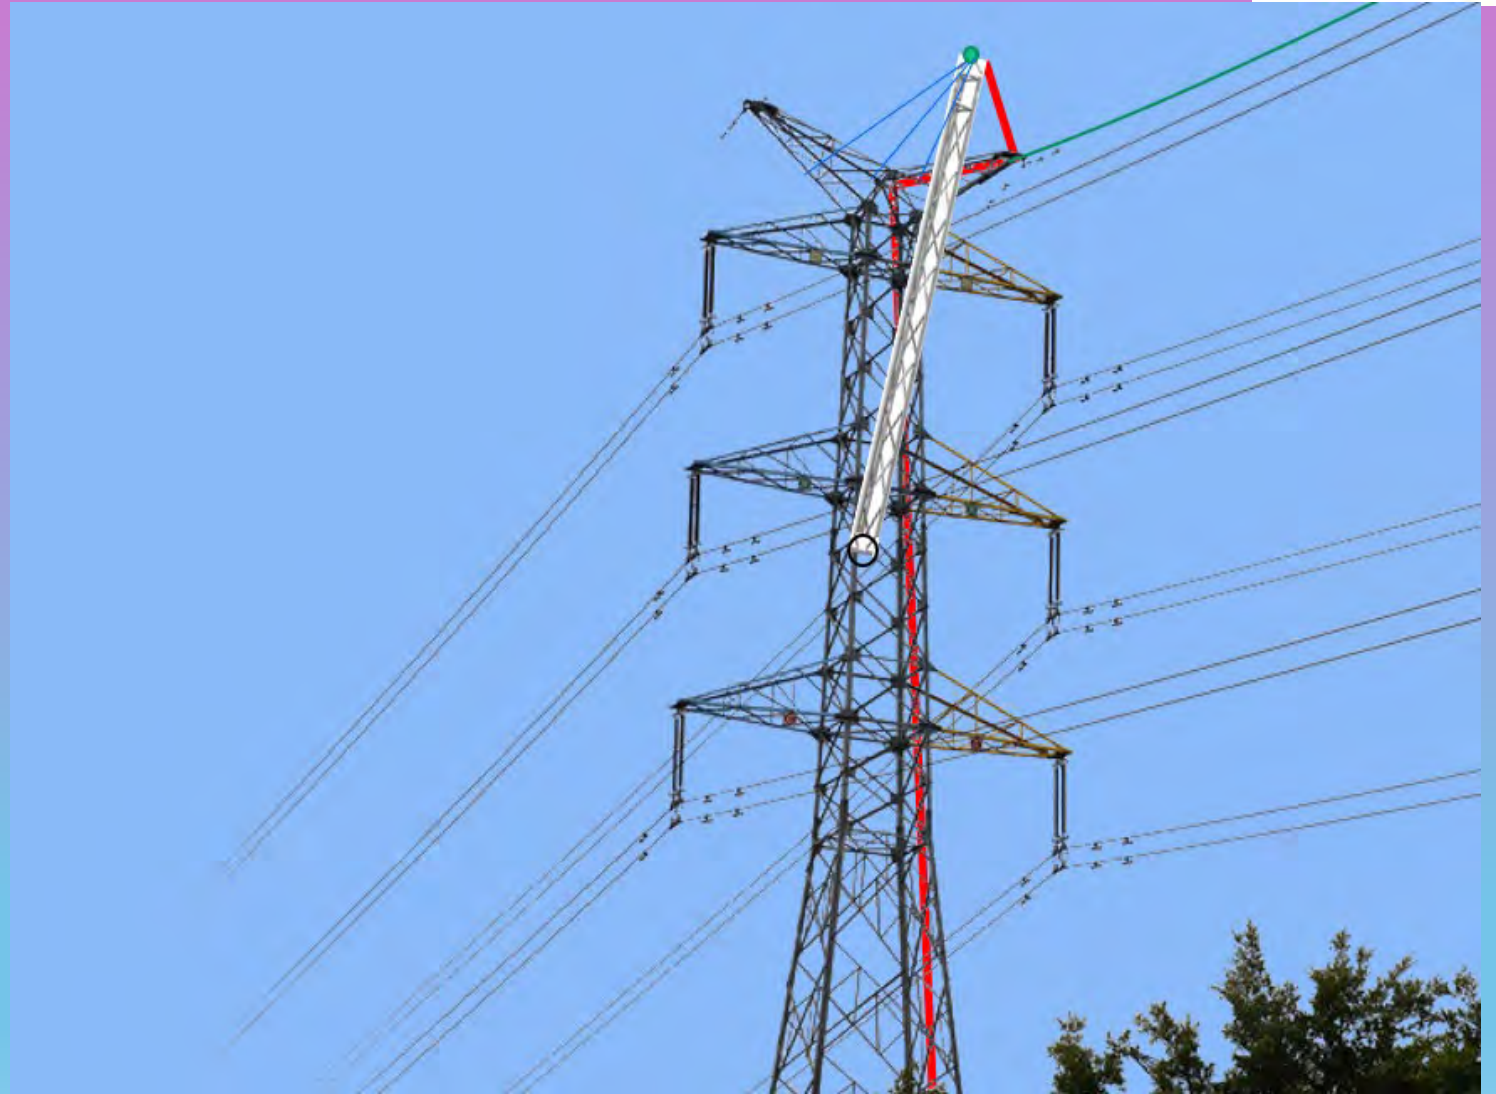
STEP 1: Crane type aluminum derrick installation

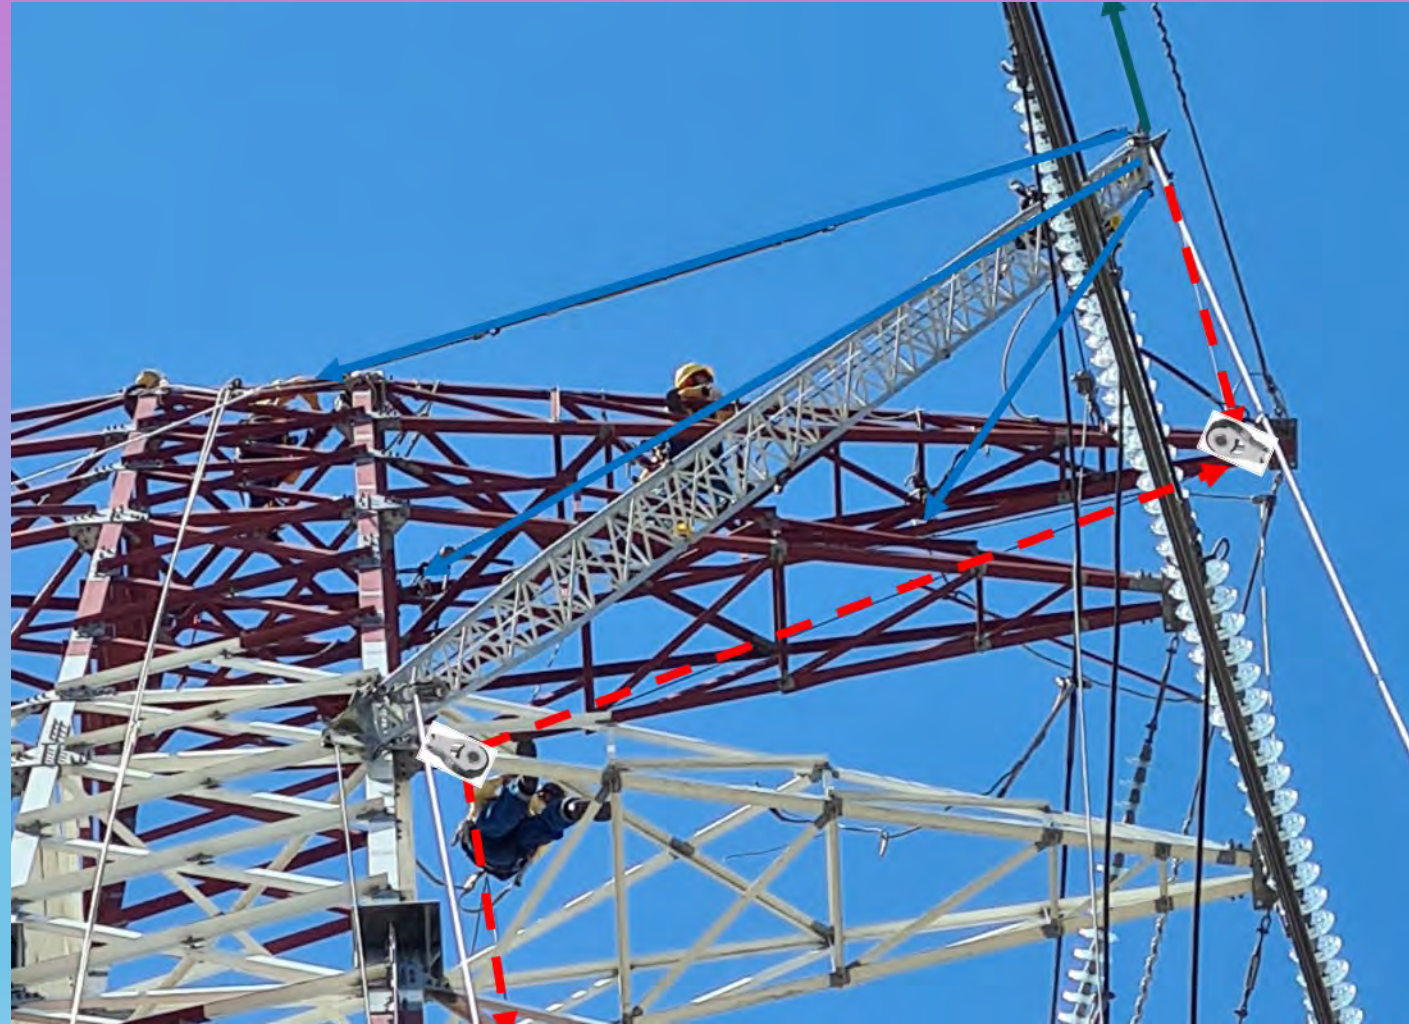
STEP 1: Crane type aluminum derrick installation

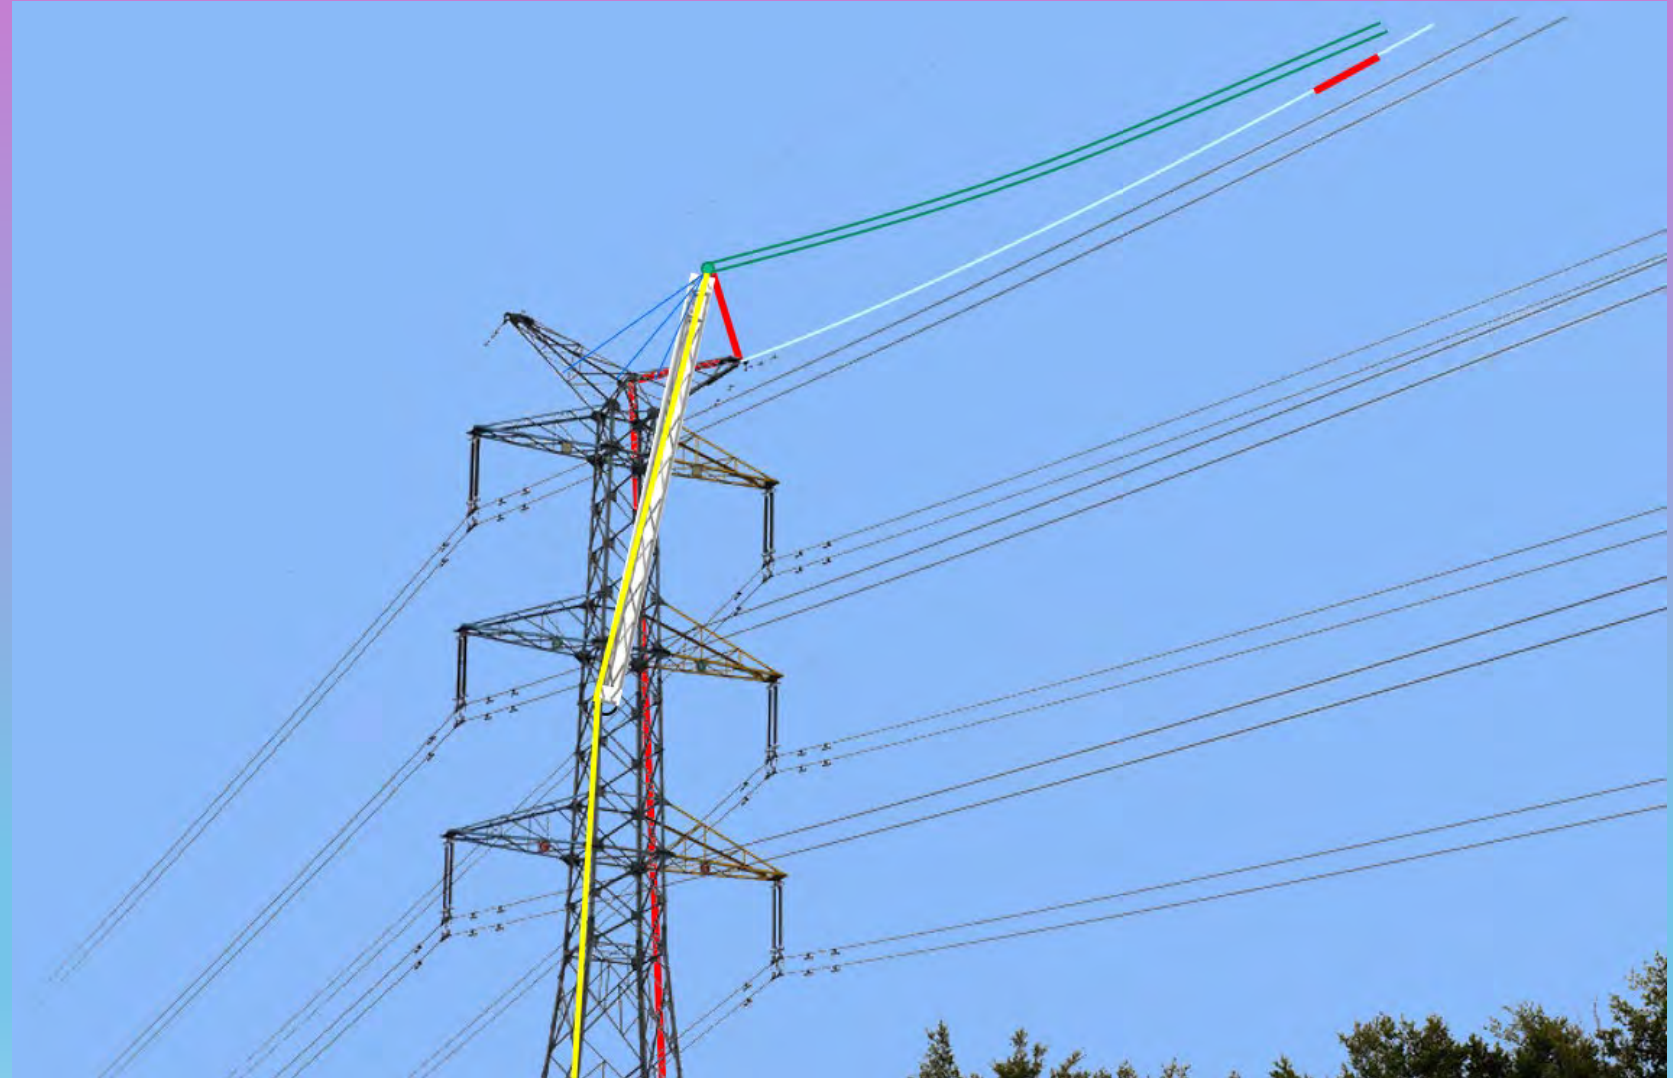
STEP 2: Installation of guide cable and safety line

-   Derrick suport cable
-   Anti twisting Steel rope
-   Derrick anchor cable
-   Support rope
-   OPGW

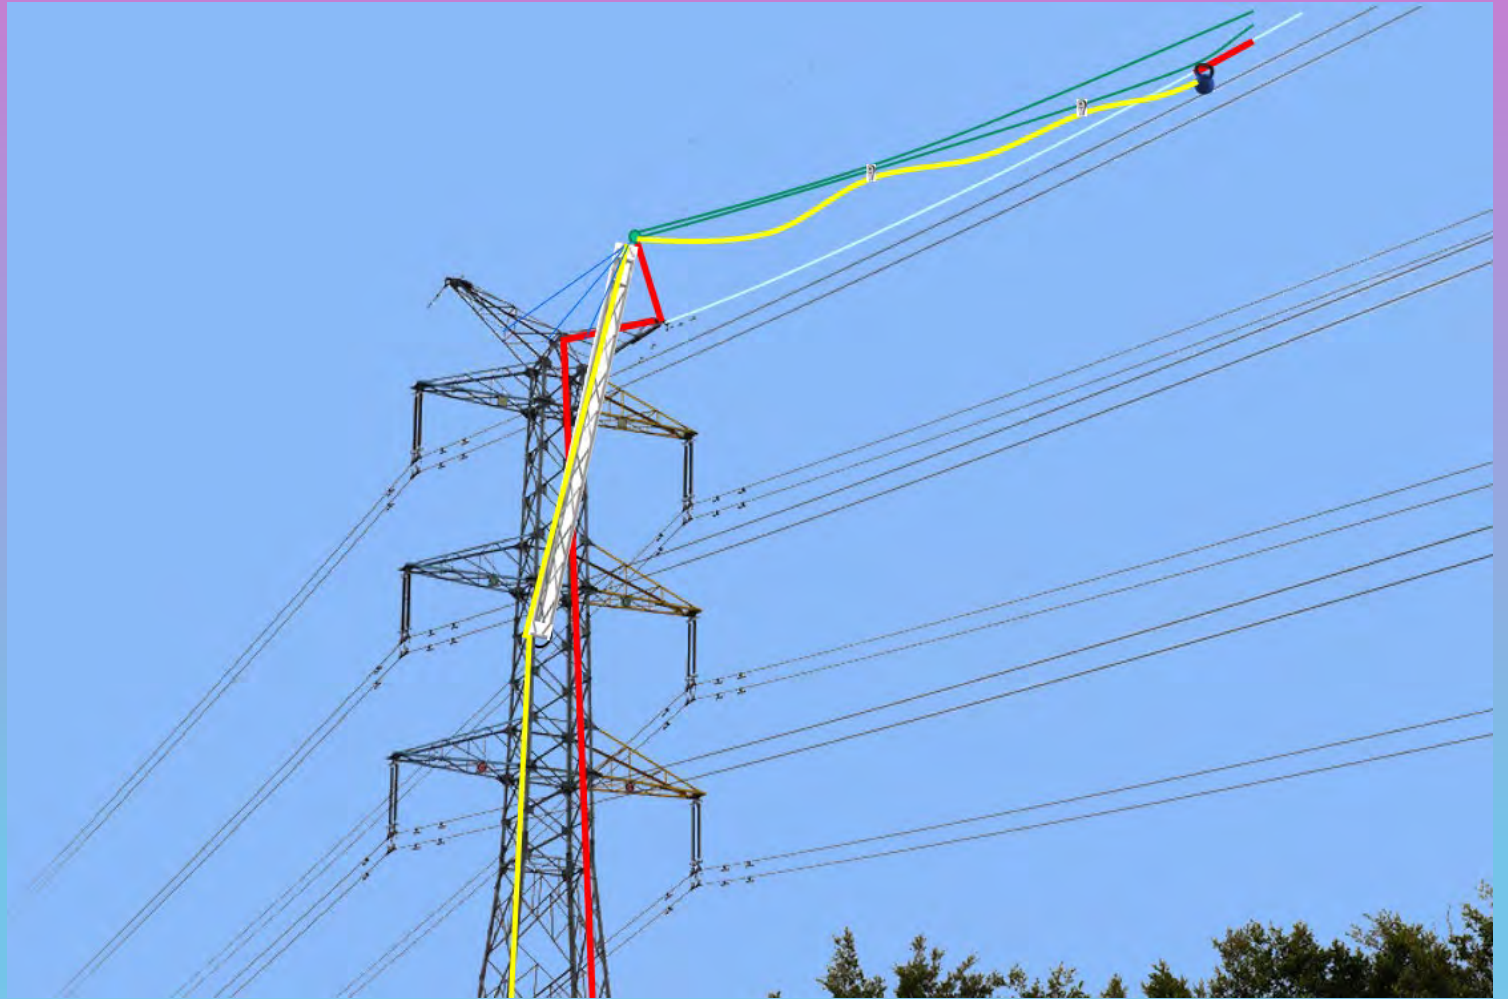
STEP 3: Test with a 220 lb (100 kg) dead weight

-   Derrick suport cable
-   Anti twisting Steel rope
-   Derrick anchor cable
-   Support rope
-   OPGW

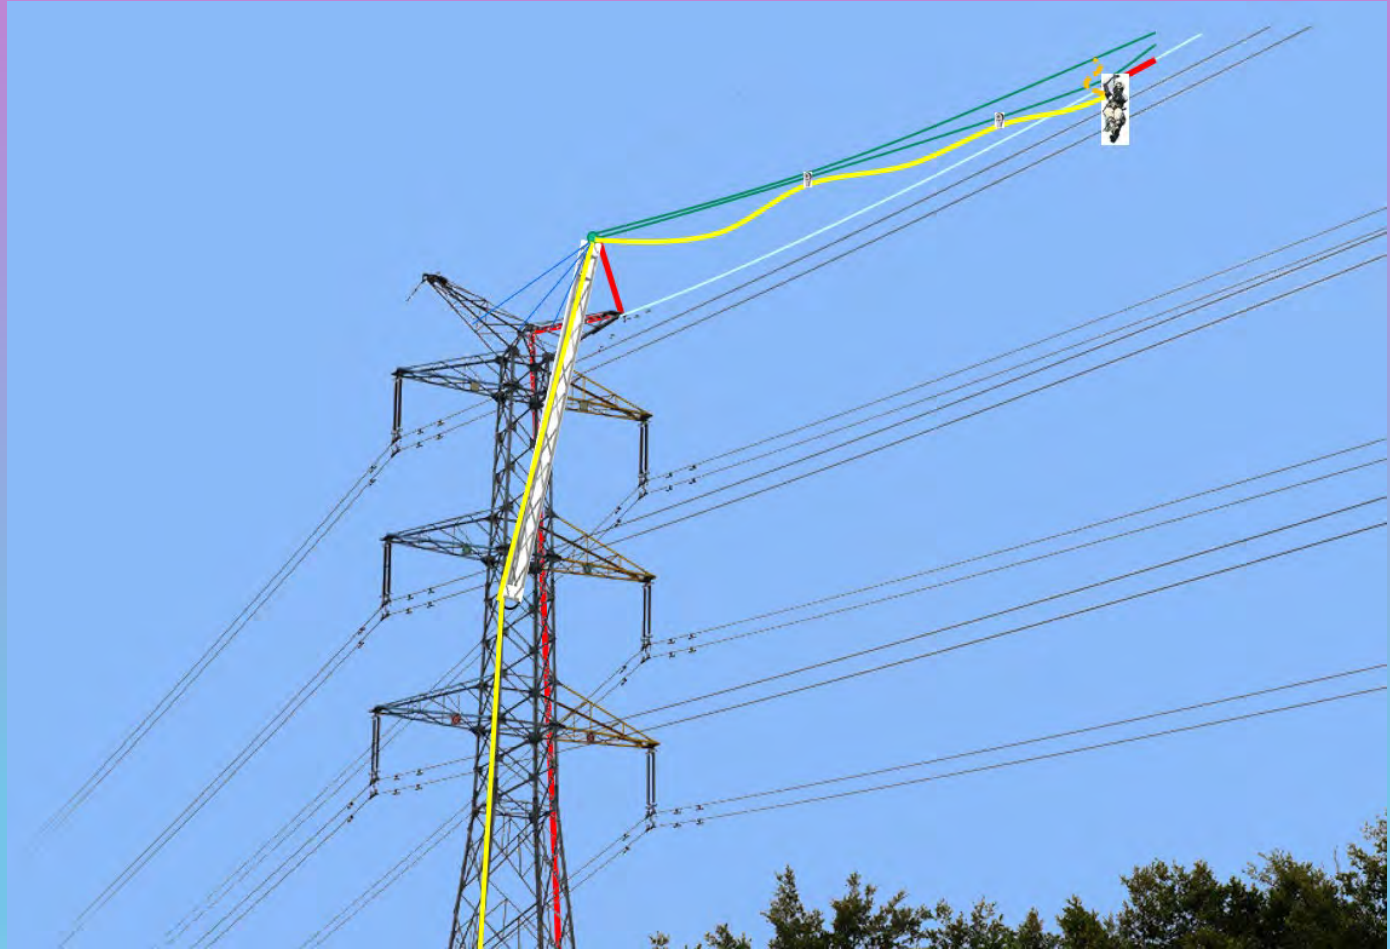
STEP 4: Lineman placed for OPGW repair

-   Derrick suport cable
-   Anti twisting Steel rope
-   Derrick anchor cable
-   Support rope
-   OPGW

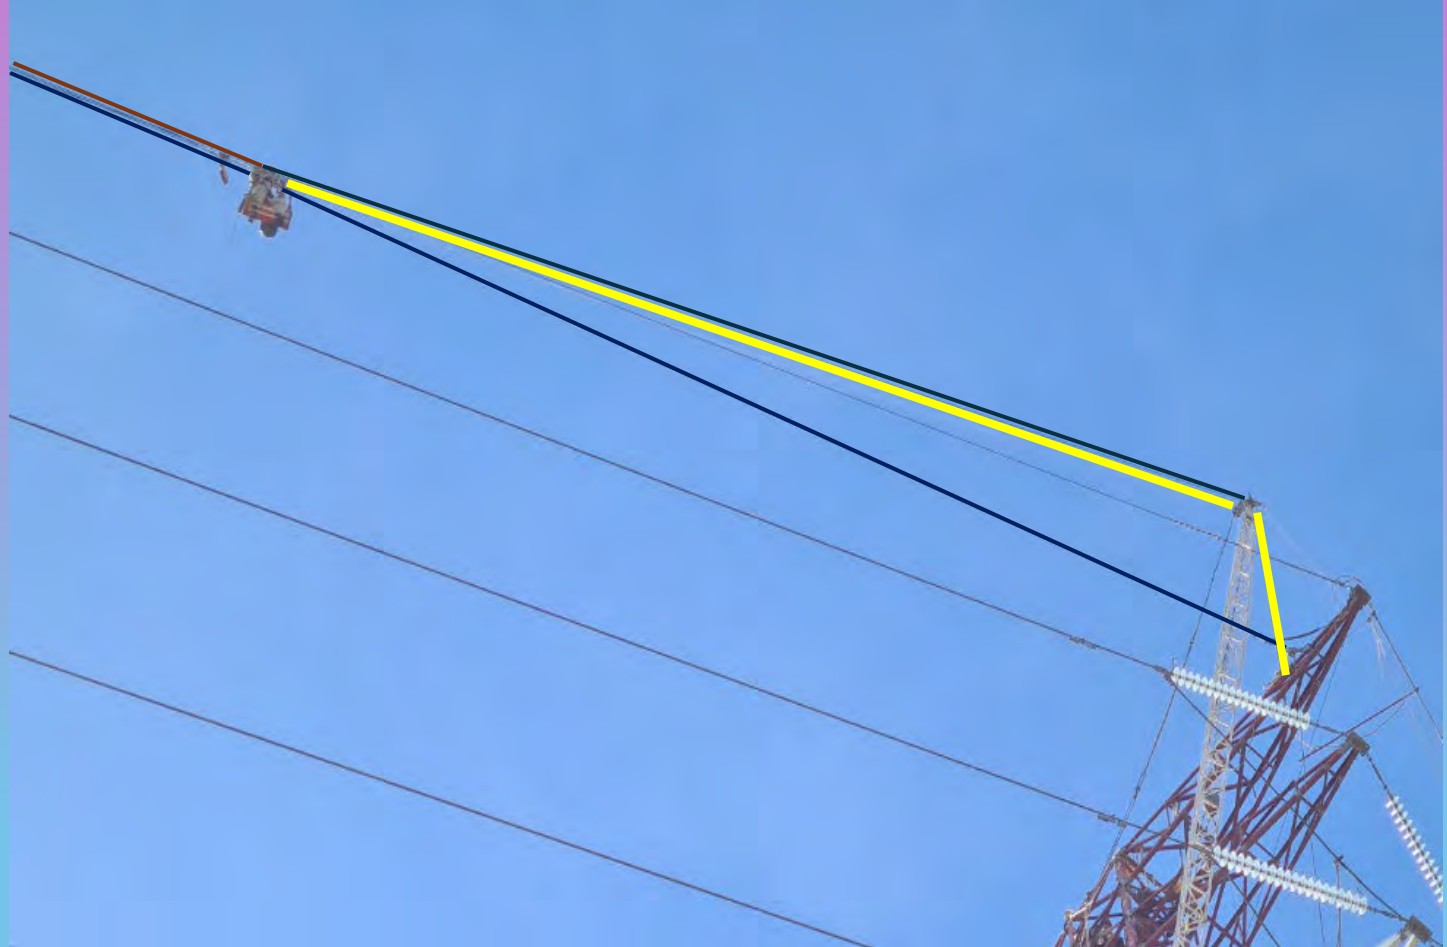
STEP 5: Lineman gets out of the line, repair finished

The repair of this OPGW was carried out without any inconvenience.

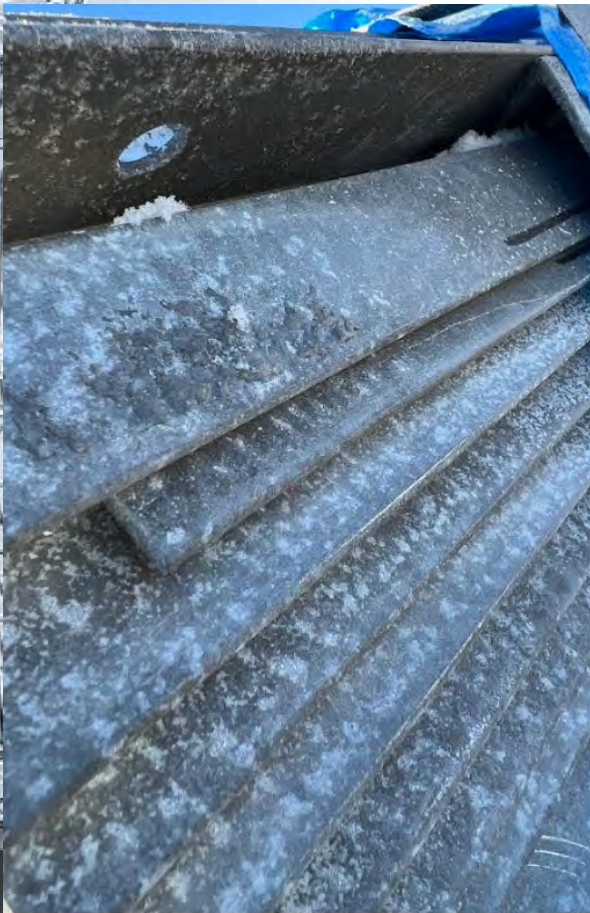
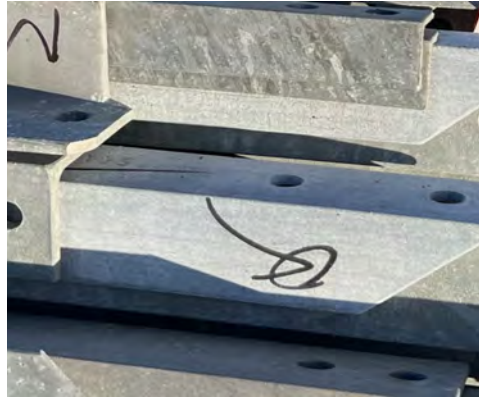
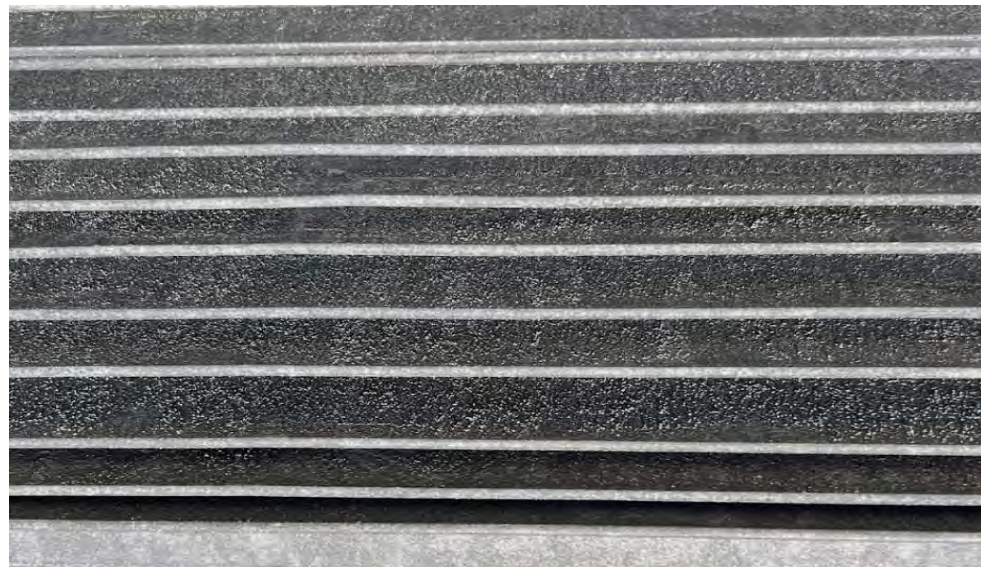
Dulling Issues

- NOT following the proper Dulling Process
- White Residue/Deposits/White Rust
- Variations in Reflectivity

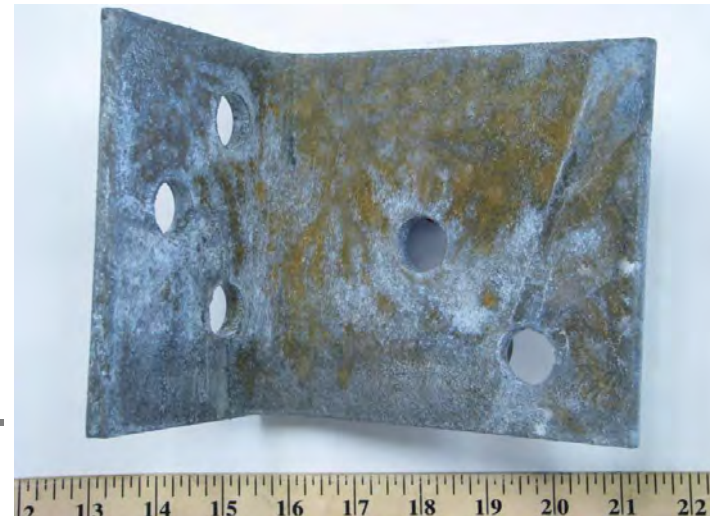
Wet Storage Stains

- Also Known as “White Residue/ Rust”
- Occur due to oxidation on a newly galvanized and dulled surface with presence of moisture and absence of free flowing oxygen
- Protective Zinc patina is not allowed to form by converting zinc oxides to zinc carbonates
- To avoid wet storage stains:
 - Proper method of transportation and storage
 - Adequate air flow
 - Prevent standing water
 - Proper method of passivation

Dulling in NOT a Passivation process.

- Establish a bundling, shipping and storage procedure to avoid wet storage stains or white rust

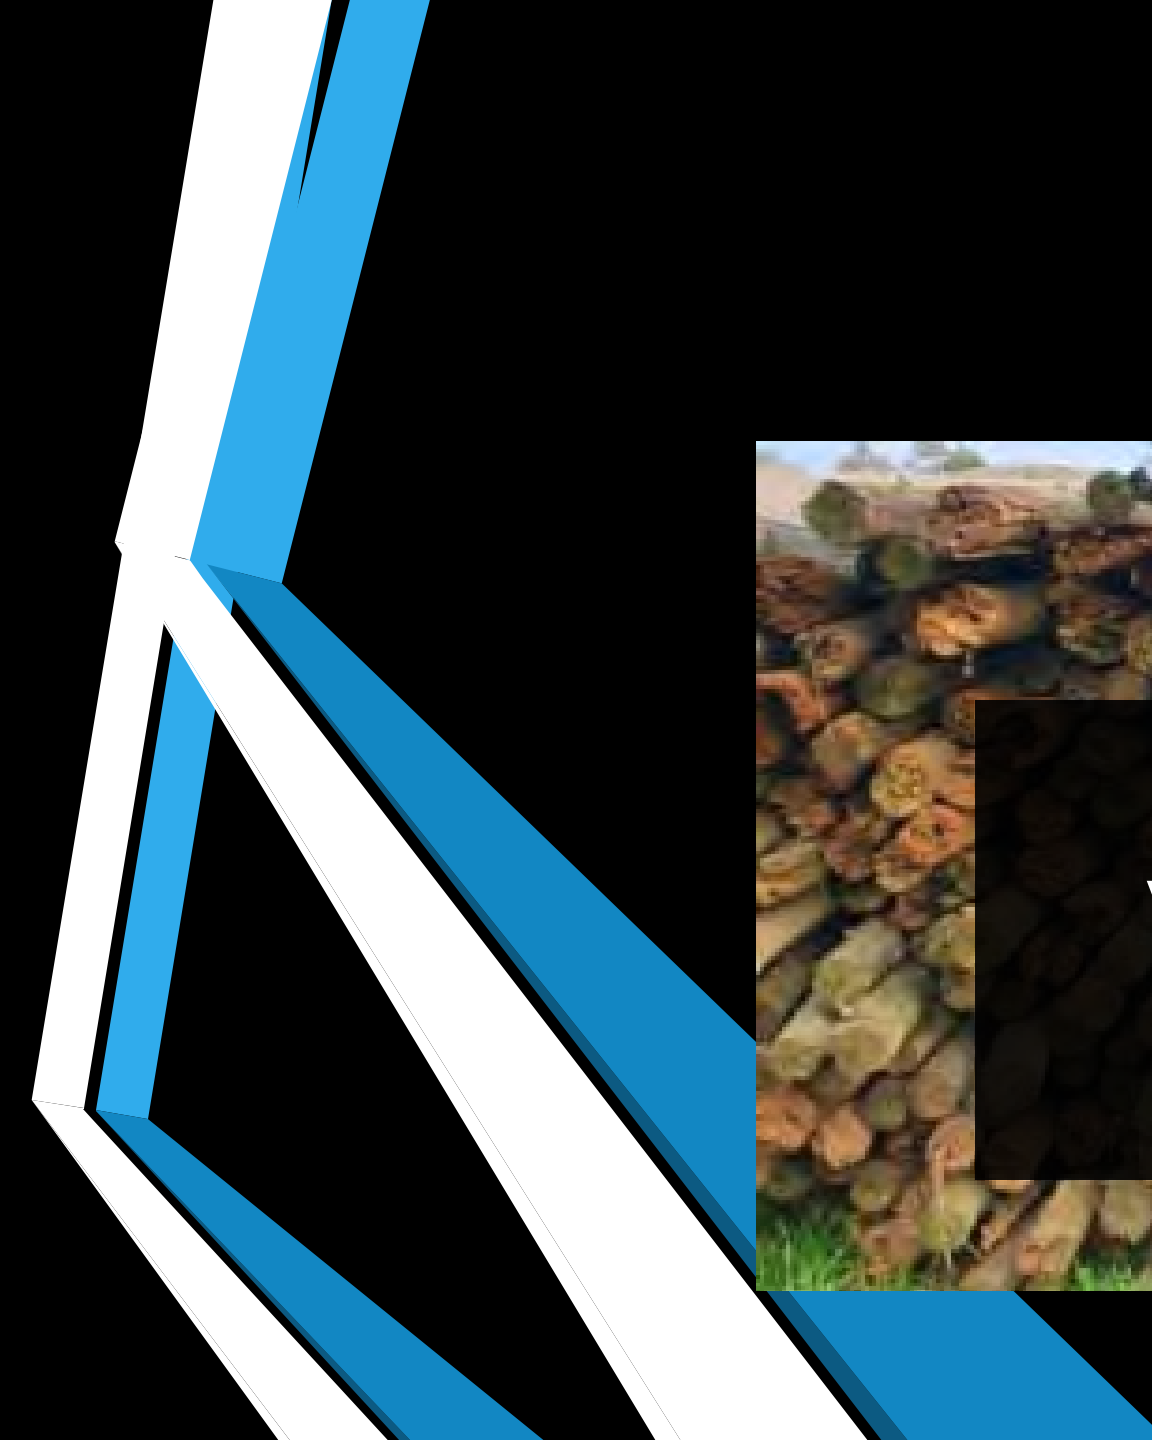
The volume of Removed Vineyard Posts in Australia By Location

ATTRITION RATE	CCA POSTS REMOVED	CREOSOTE POSTS REMOVED	TOTAL POSTS REMOVED
NEW SOUTH WALES	2%	300040	155329	455369
QUEENSLAND	2%	5950	715	6665
SOUTH AUSTRALIA	2%	682061	185008	867069
TASMANIA	2%	20639	0	20639
VICTORIA	2%	230857	46377	277234
WESTERN AUSTRALIA	2%	96727	0	96727
NATIONAL	2%	1336275	387430	1723705

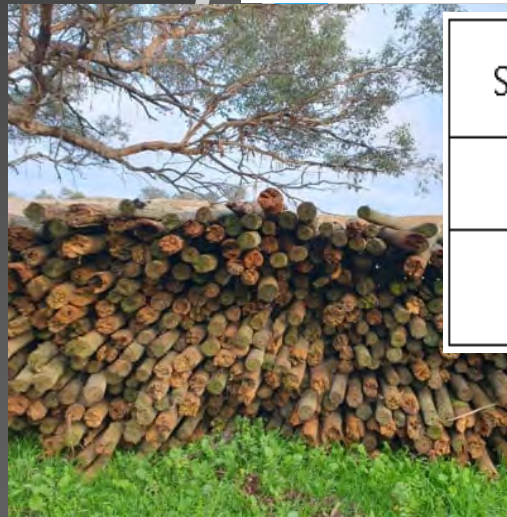
SOUTH AUSTRALIA	CCA POSTS REMOVED	CREOSOTE POST REMOVED	TOTAL POSTS REMOVED
All regions at 2%	682061	185008	867070
<u>Langhorn Ck & Riverland</u> 15%	2472607	736784	3209391

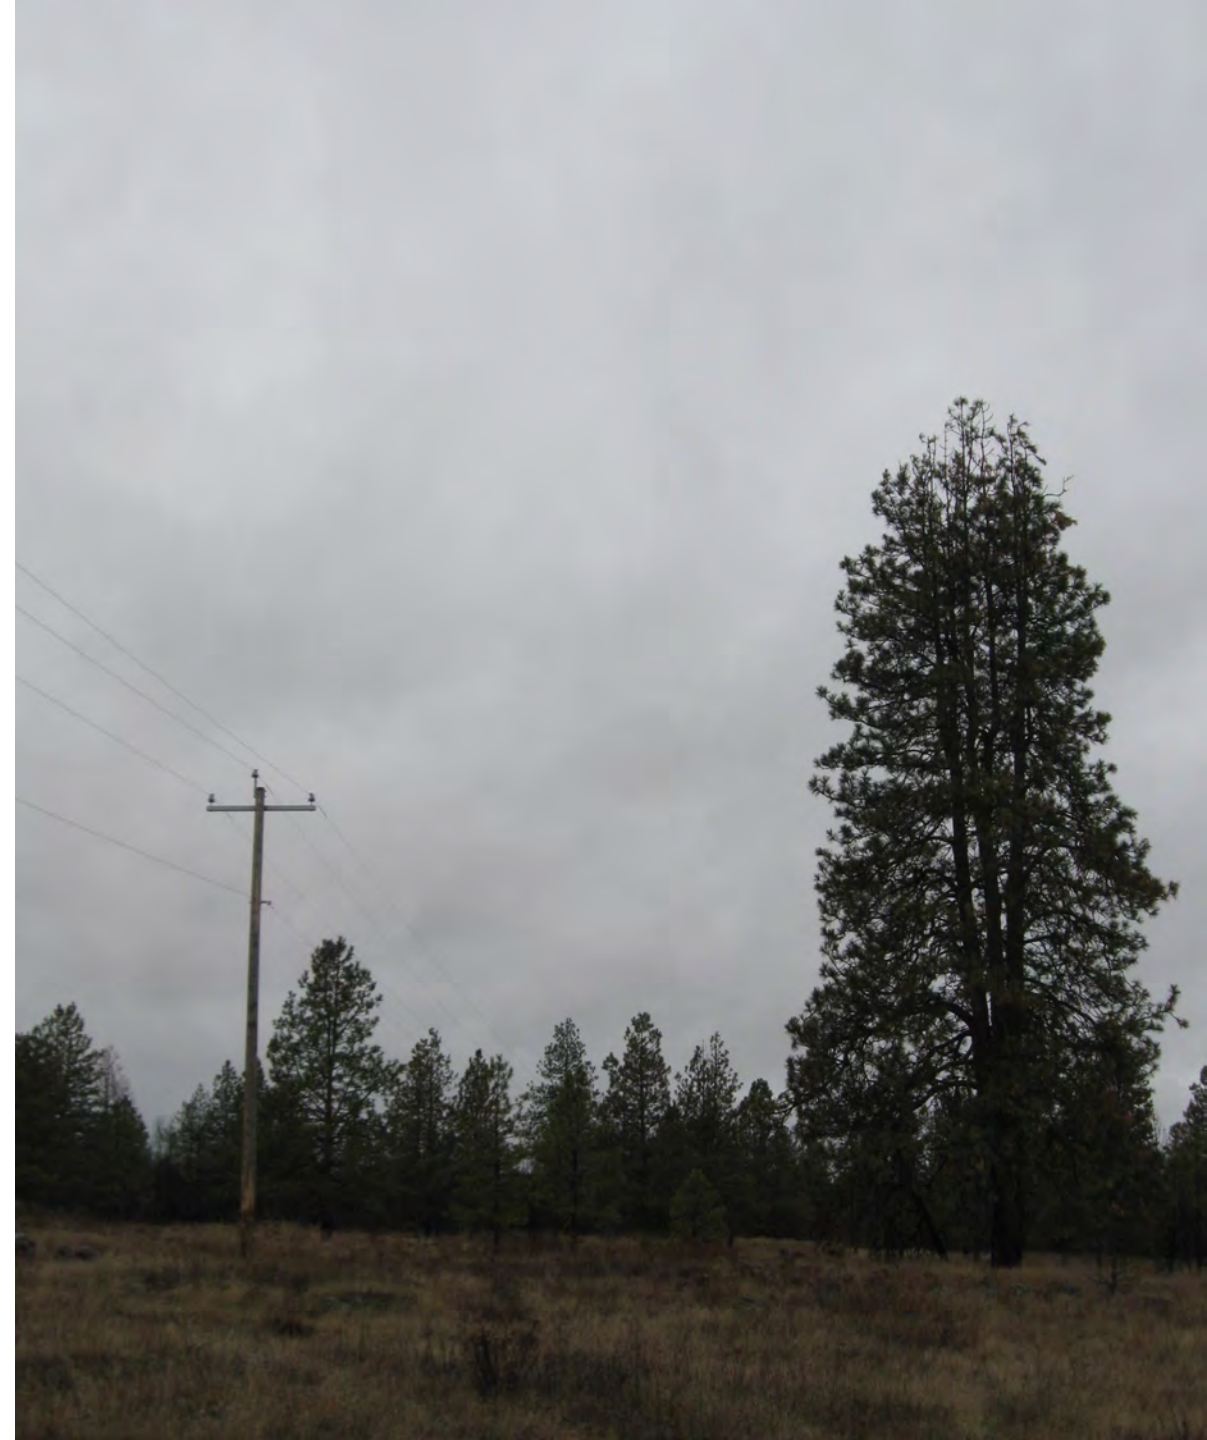
CODOMINANT STEMS AND TRUNKS

Codominant stems: Two stems growing from the same point of attachment, and are of equal or similar size (diameter). Codominant stems, per se, are not inherently hazardous.

Shown: Codominant stems, requiring monitoring versus immediate removal.

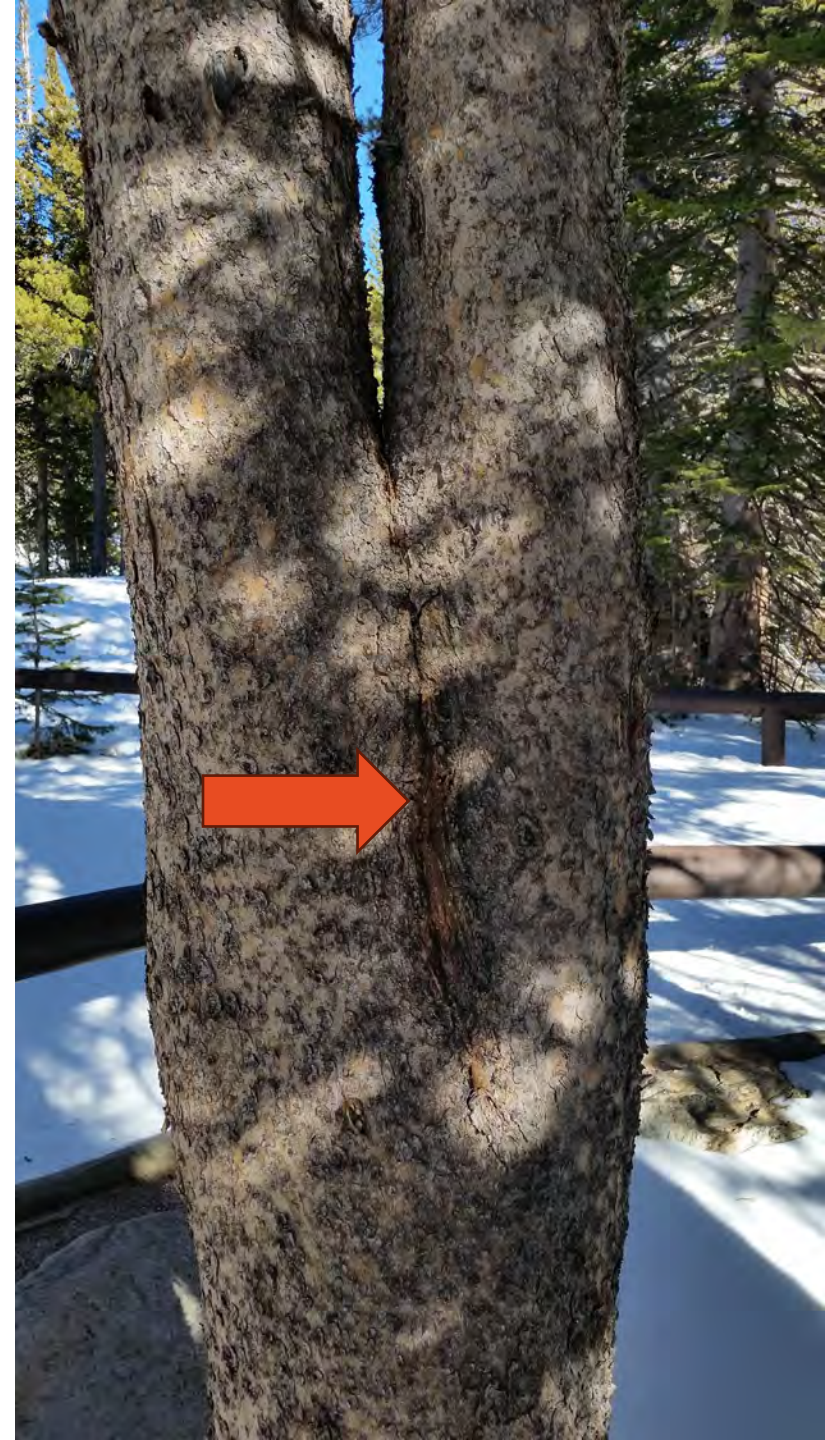
Defective, structurally unsound codominant stems. History of splits/cracks below the stem union. Cracks may appear to be open or closed, but either way, represent a potential hazard.

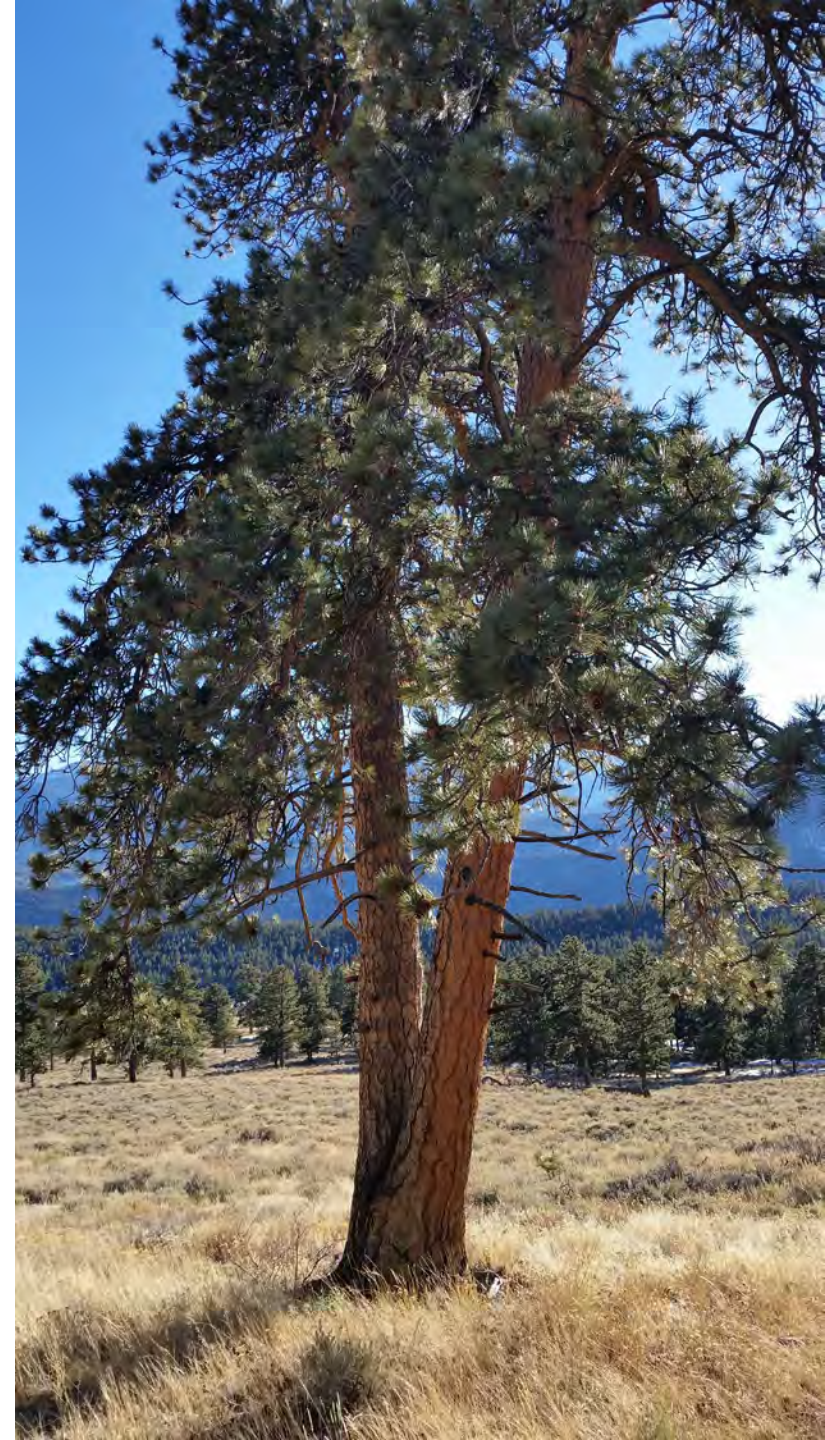
Structurally unsound codominant trunks.
History of splits/cracks at and below the trunk
union. Tree removal is the only option.

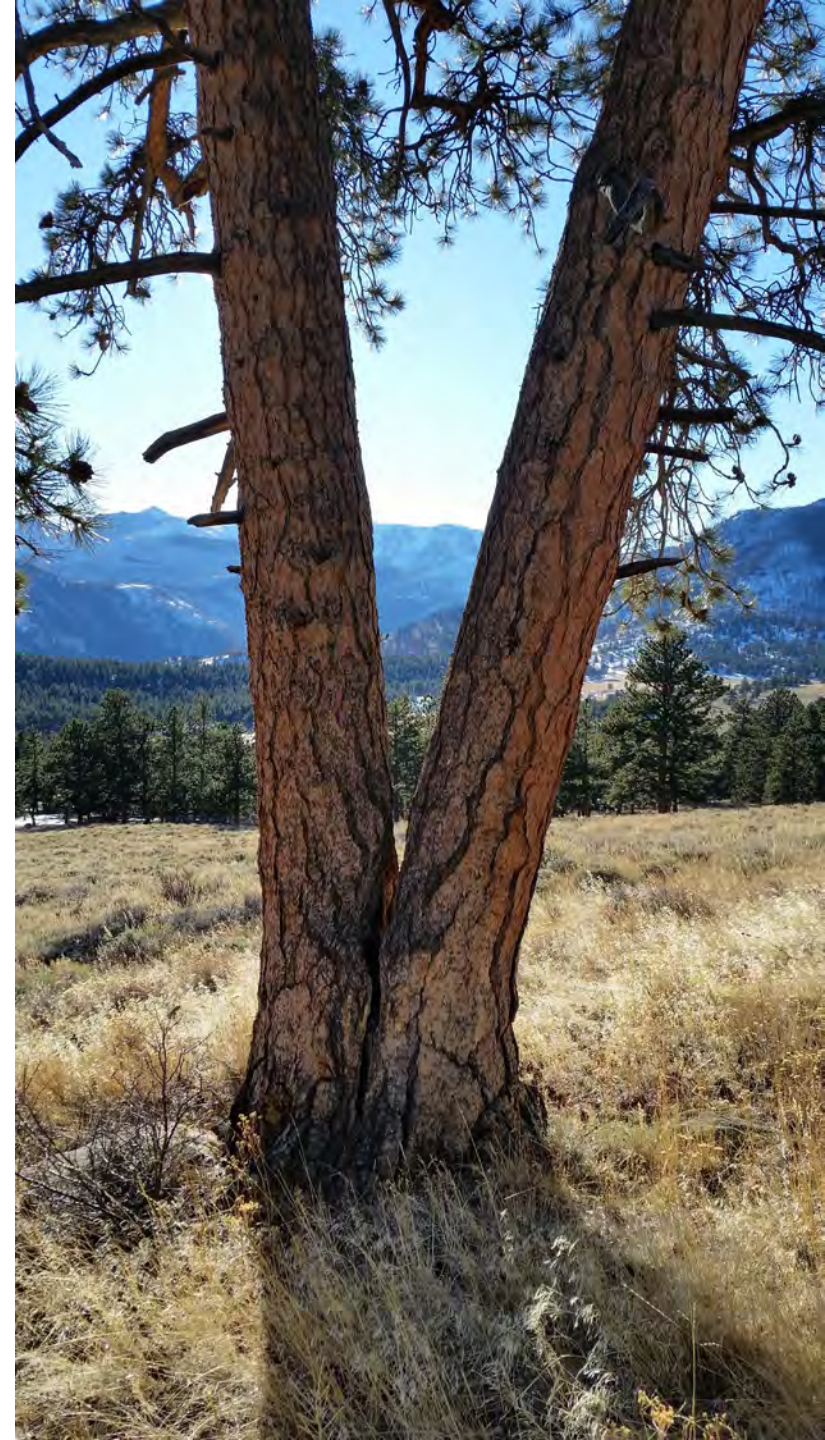
Structurally unsound codominant trunks.
History of splits/cracks at and below the trunk
union. Tree removal is the only option.

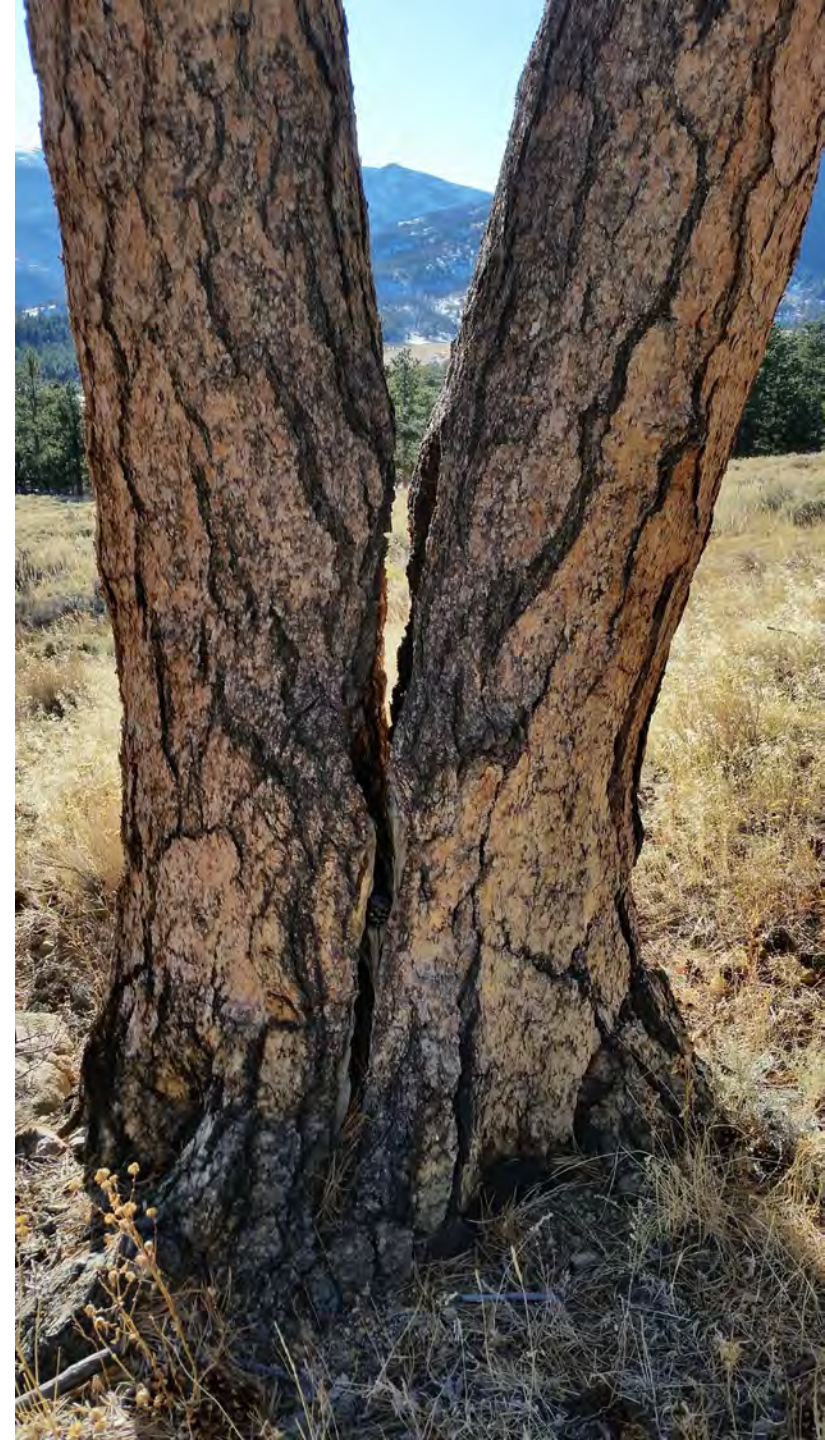
1. DEFECTIVE CODOMINANT STEMS AND TRUNKS

Defective, structurally unsound codominant stems. Stems may be solid wood, but the attachment is weak and hazardous.
