Transmission Division

Method for repairing OPGW in proximity to energized conductors

The objective of this work is to present a procedure for the repair of a damaged OPGW conductor, in the proximity of energized transmission lines of 138 kV or higher.

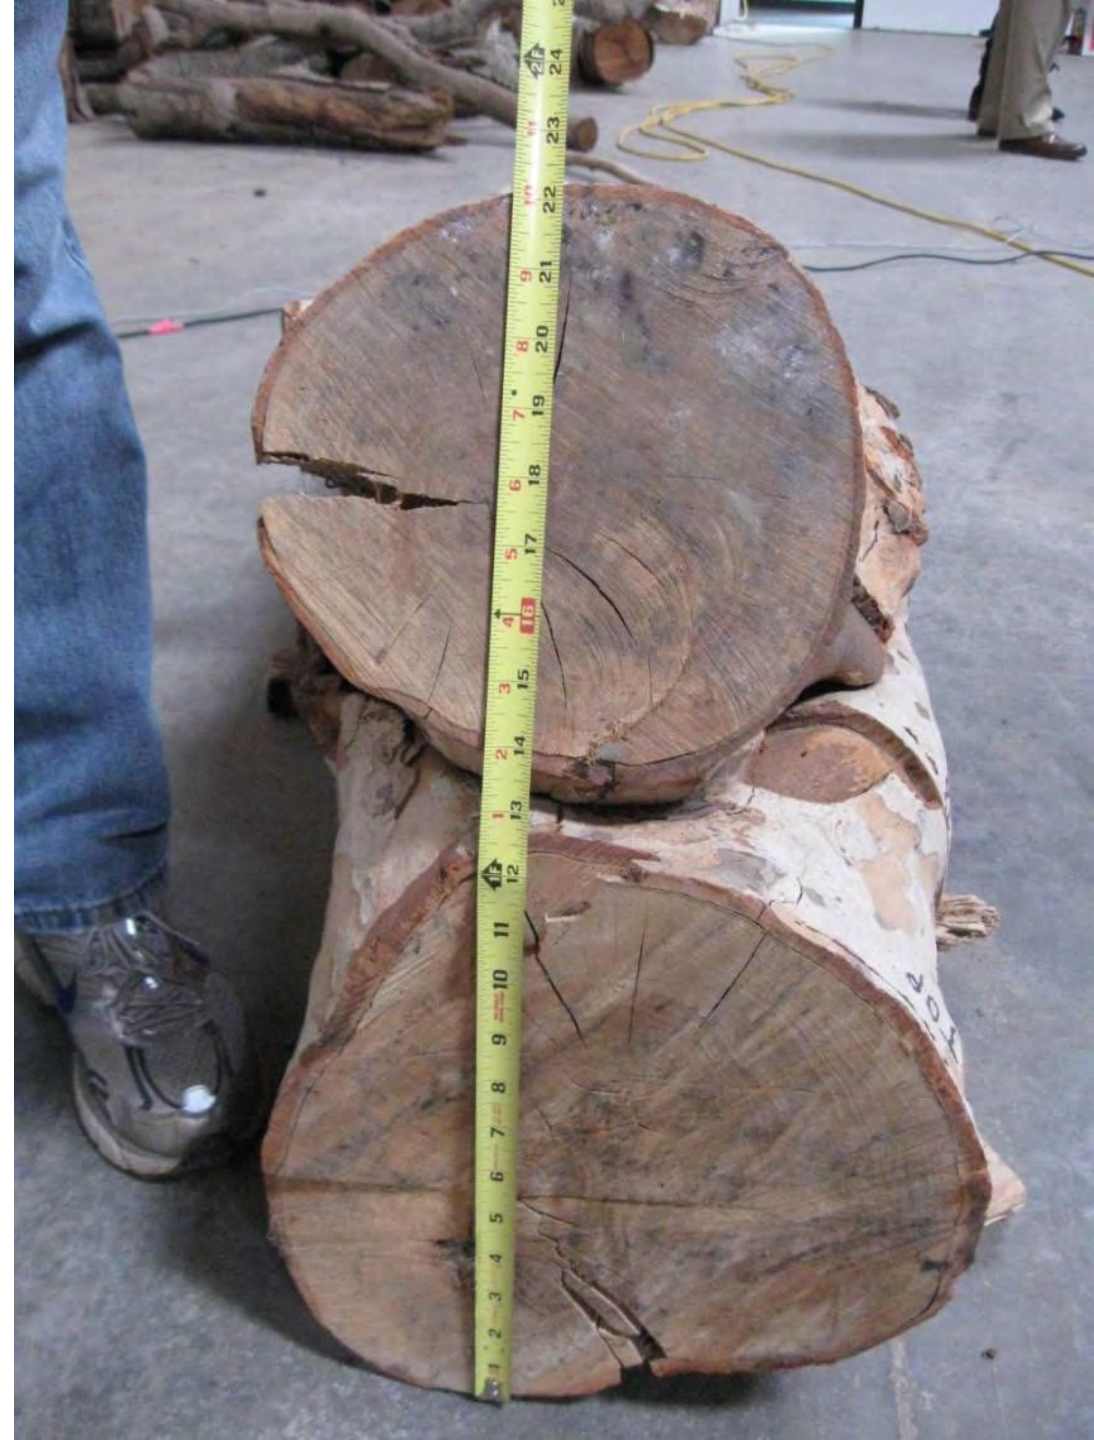
1. DEFECTIVE CODOMINANT STEMS AND TRUNKS

Defective, structurally unsound codominant stems. History of splits/cracks at and below the stem union. This was the area of failure which resulted in contact with a distribution line.

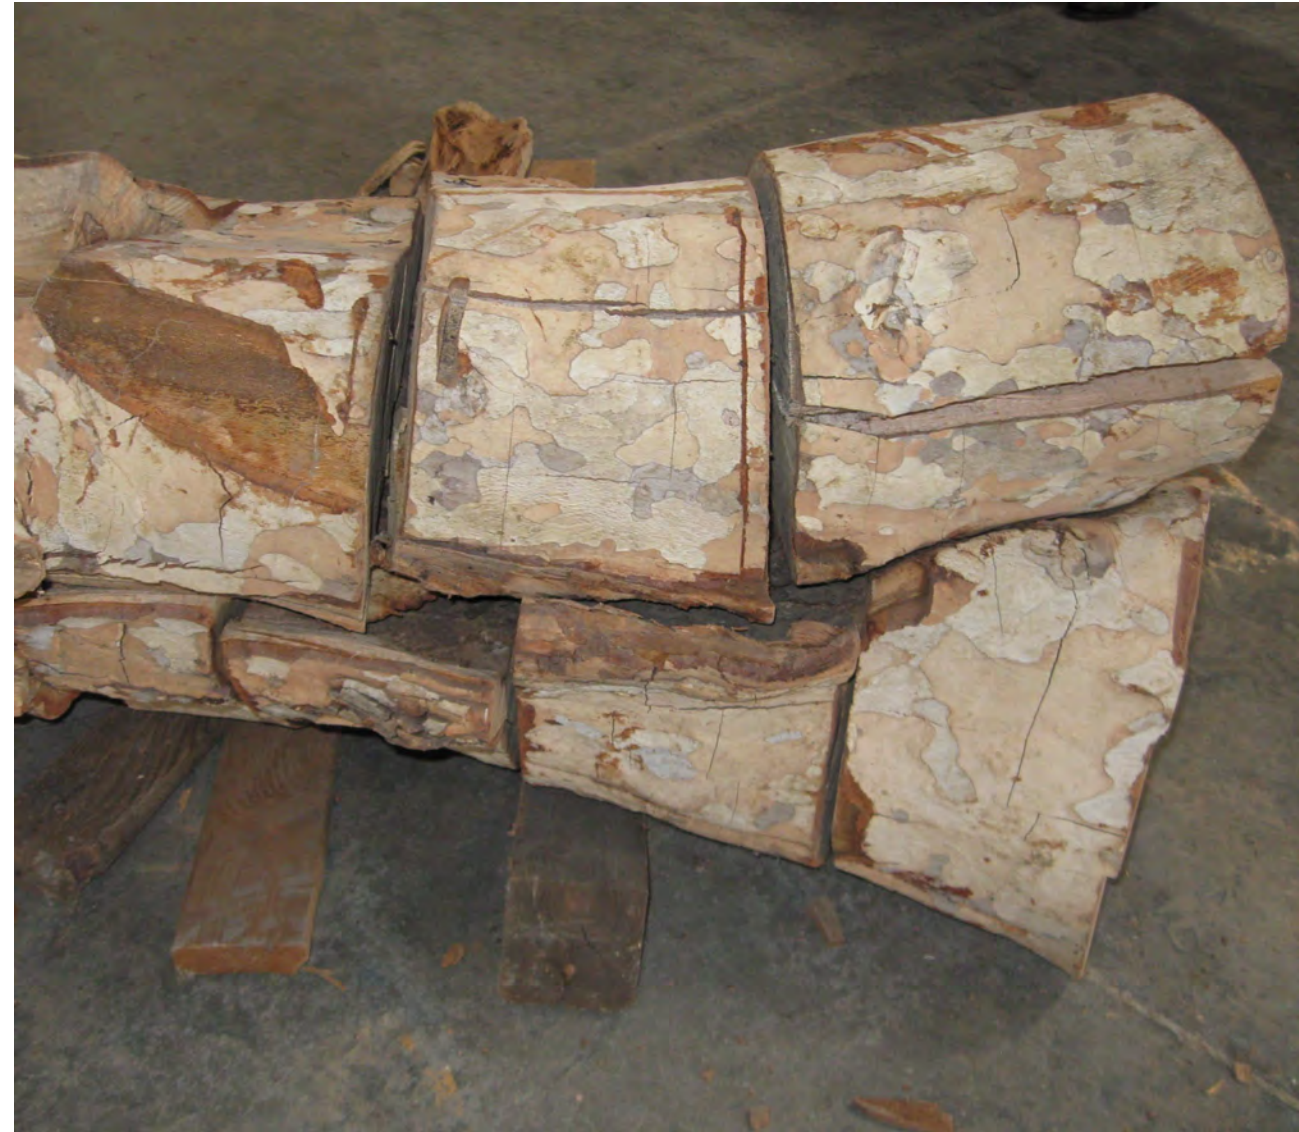
1. DEFECTIVE CODOMINANT STEMS AND TRUNKS

Defective, structurally unsound codominant stems. Embedded bark with no fused wood contact, indicating a weak attachment. Bark does not fuse together, as does wood.

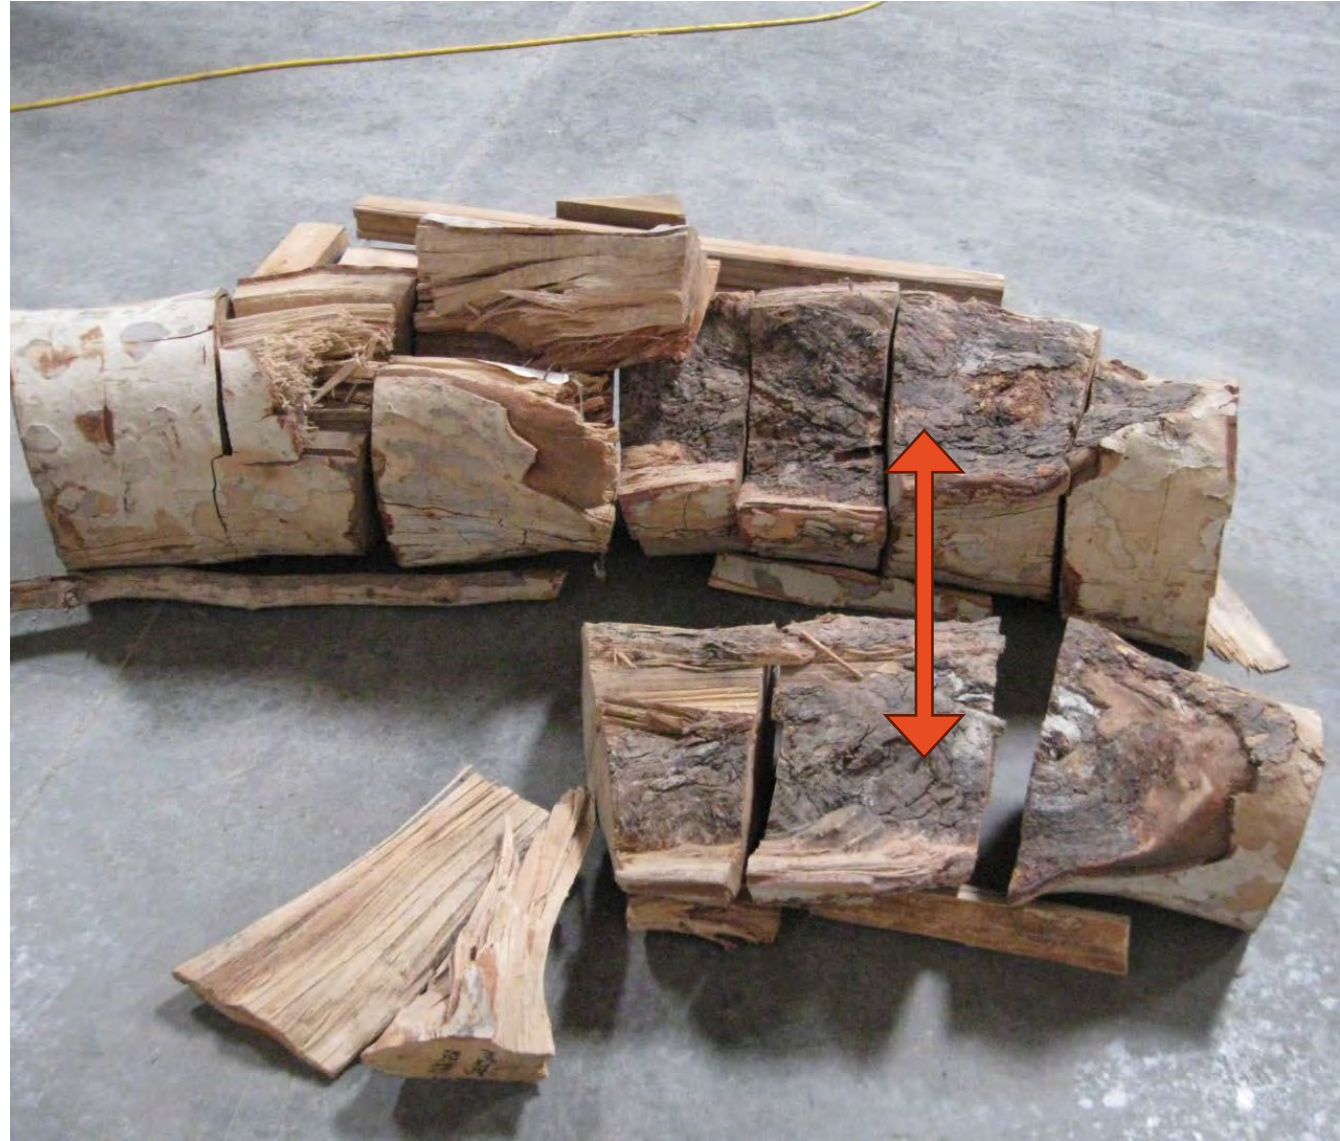
1. DEFECTIVE CODOMINANT STEMS AND TRUNKS

Defective, structurally unsound codominant stems. Note development of woundwood ribs (excessive wood growth) as an indicator of a tree's natural response to defects.

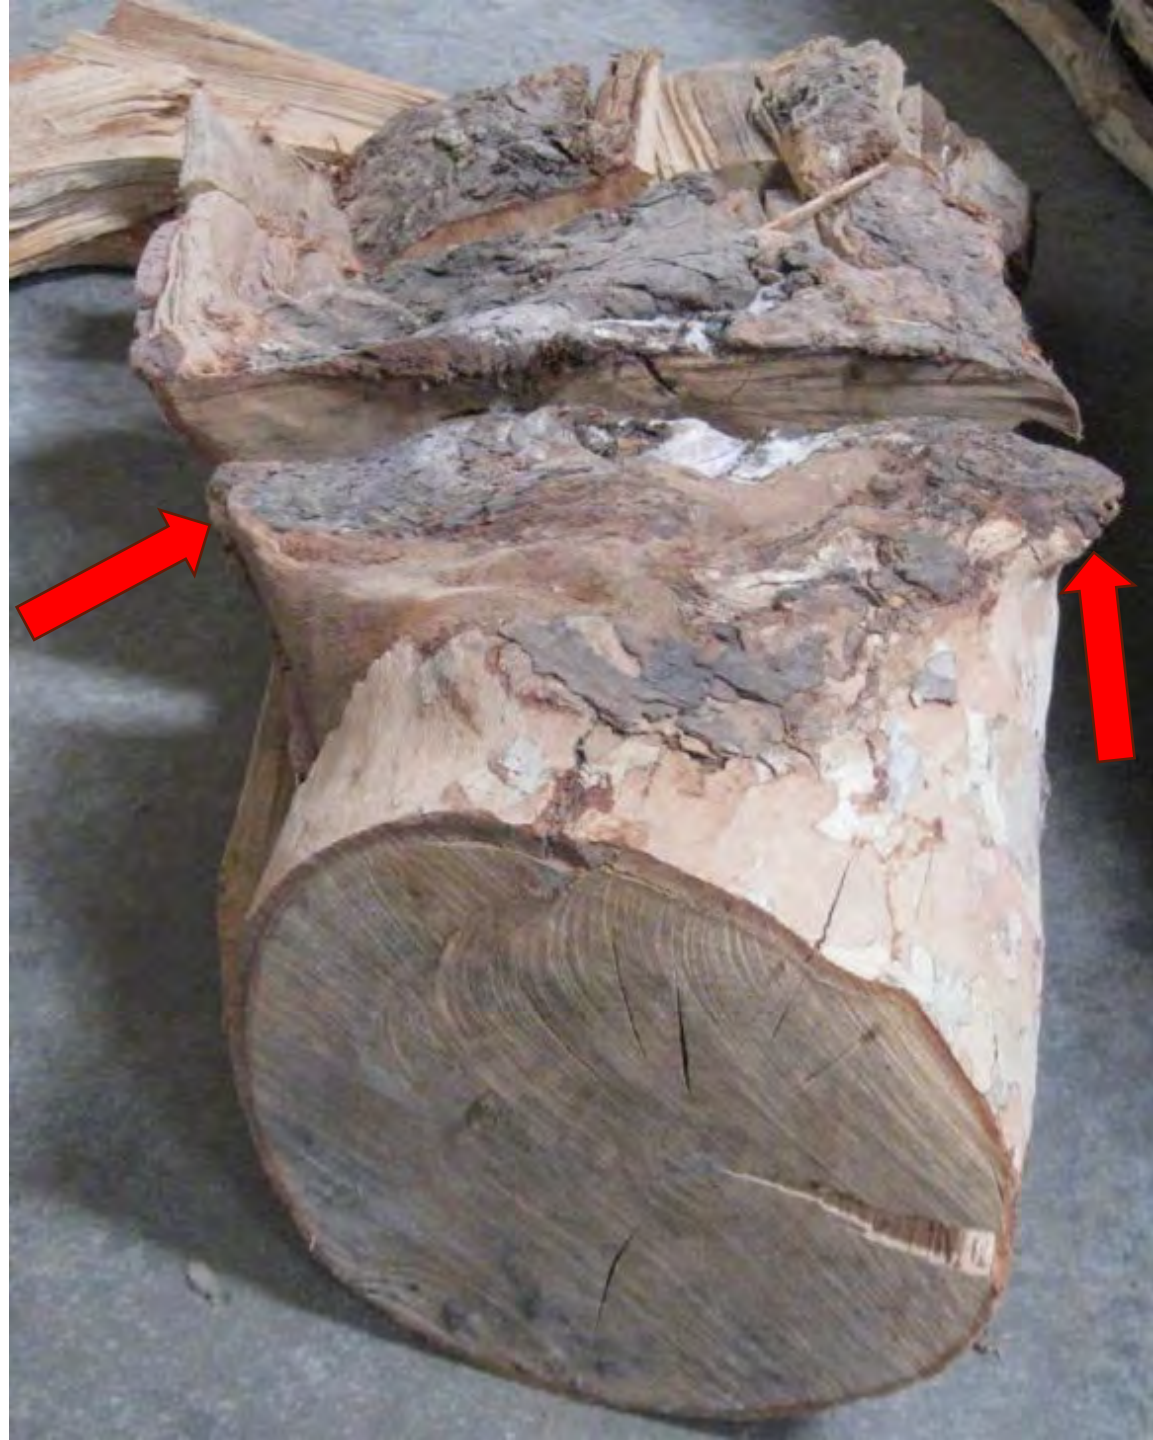
2. HIDDEN EXTERNAL CAVITIES AND OLD FIRE SCARS

Gray pine with a lean toward conductors within strike distance. Suspect tree is outside of the utility easement/R.O.W., which is often the case.

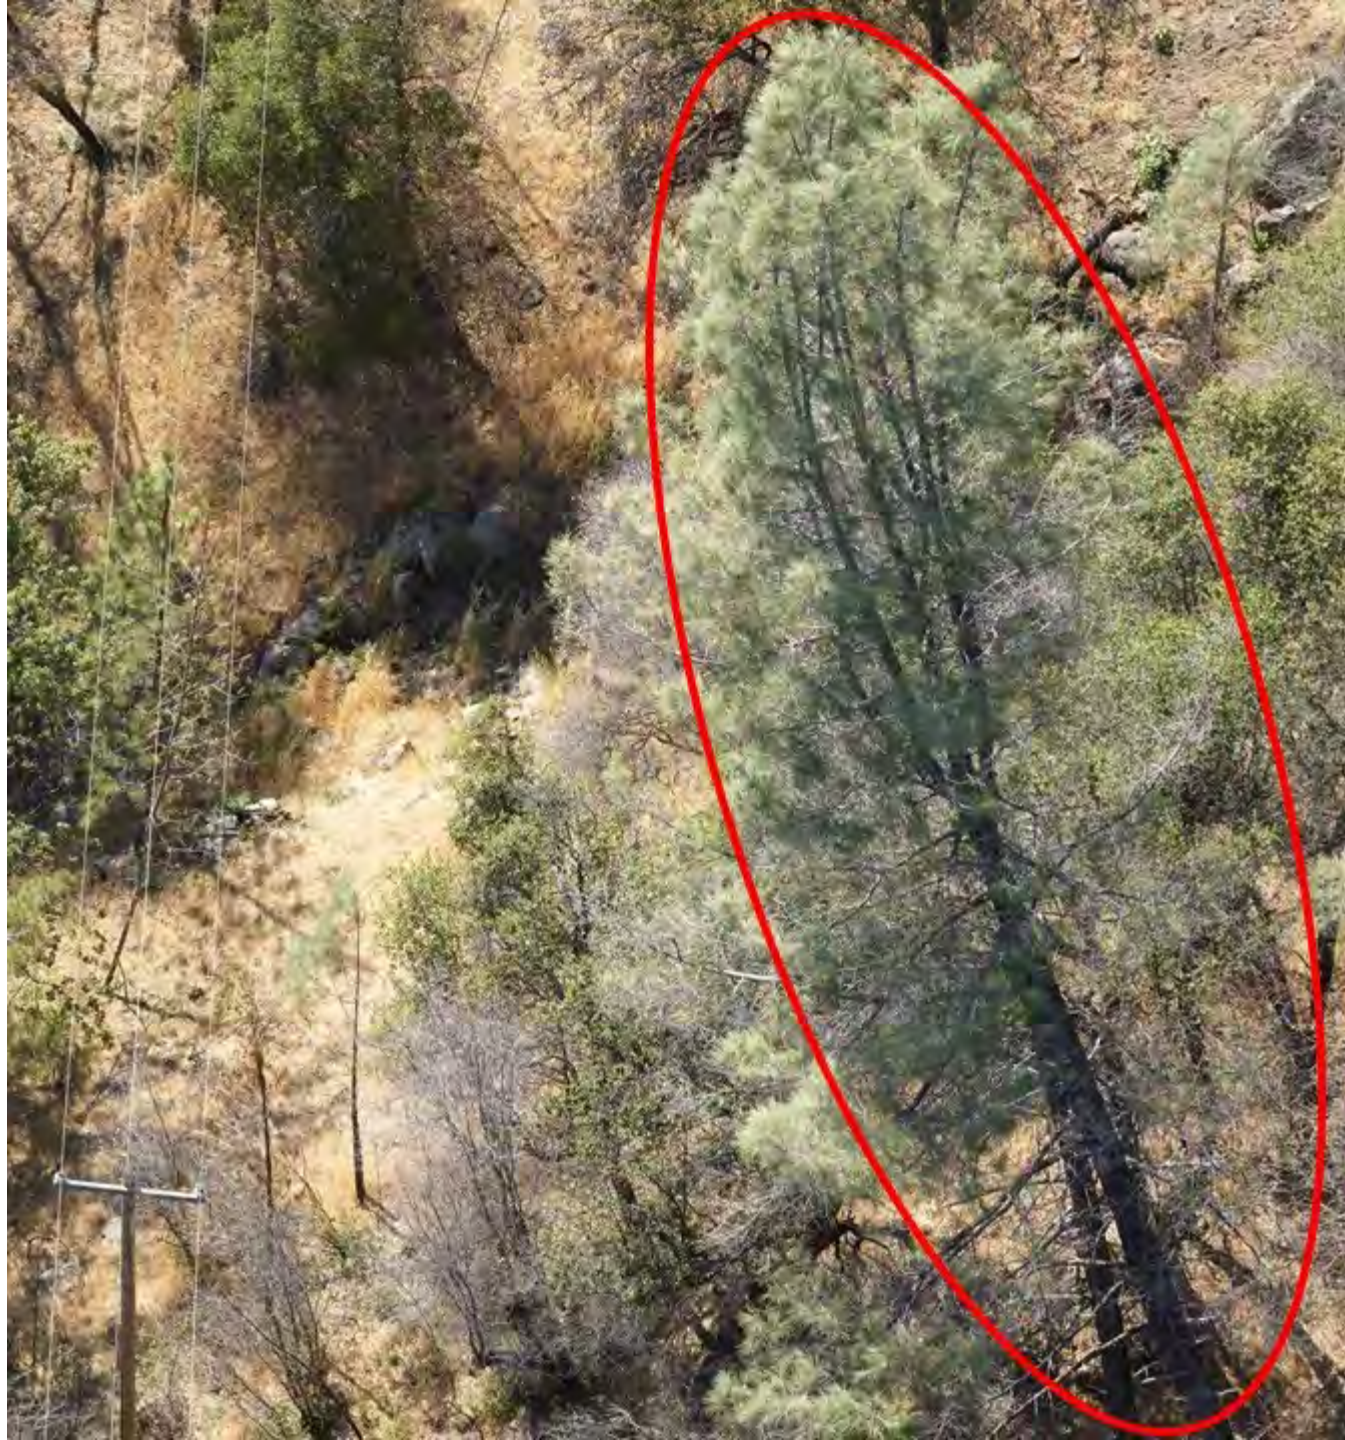
2. HIDDEN EXTERNAL CAVITIES AND OLD FIRE SCARS

Base of the same gray pine after failure, showing old fire scar, trunk decay, and loss of major anchor roots—all of which were hidden from normal utility easement view angles.

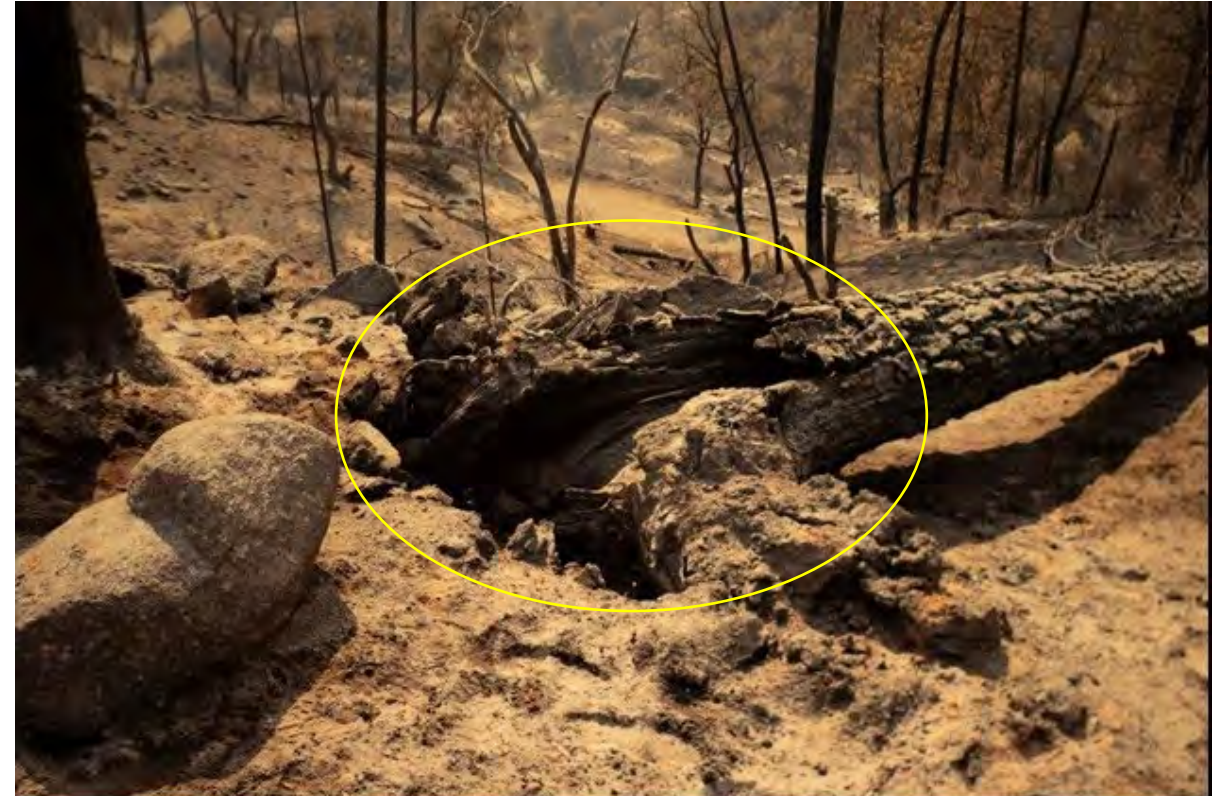
2. HIDDEN EXTERNAL CAVITIES AND OLD FIRE SCARS

Base of pine with old fire scar and open cavity, exposing extent of remaining holding wood.
All of these indicators were hidden from view along the utility corridor (road) in background.

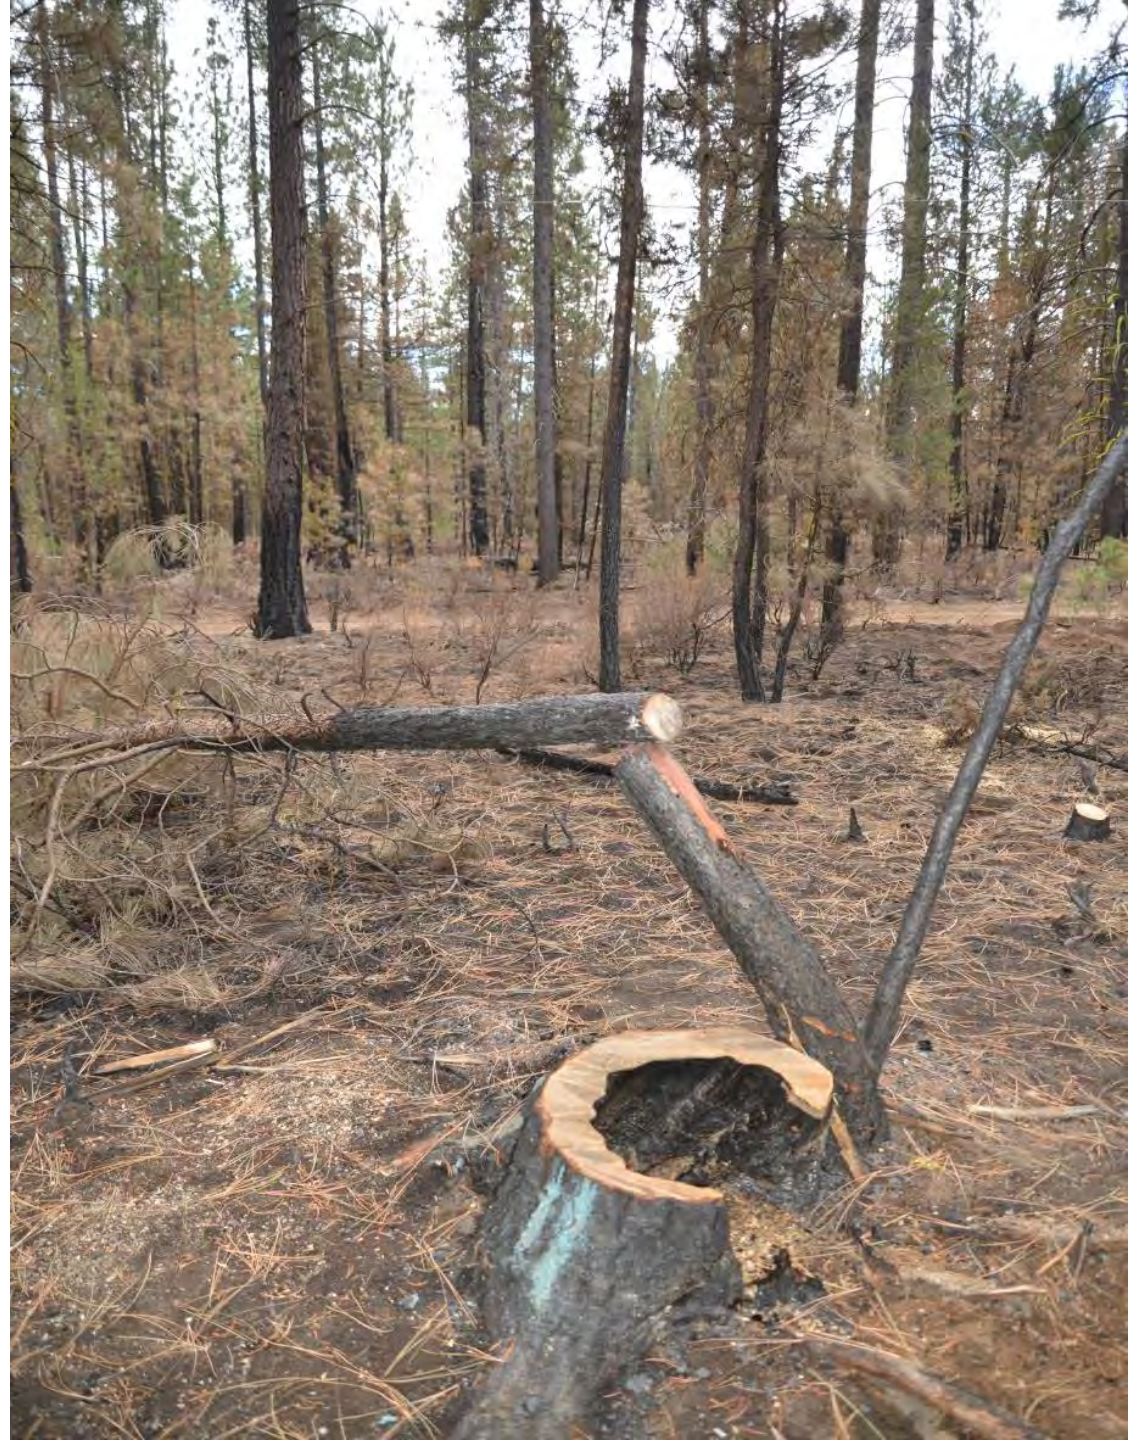
2. HIDDEN EXTERNAL CAVITIES AND OLD FIRE SCARS

Same pine stump as viewed from the utility corridor (easement). Open cavity and old fire scar are not visible.

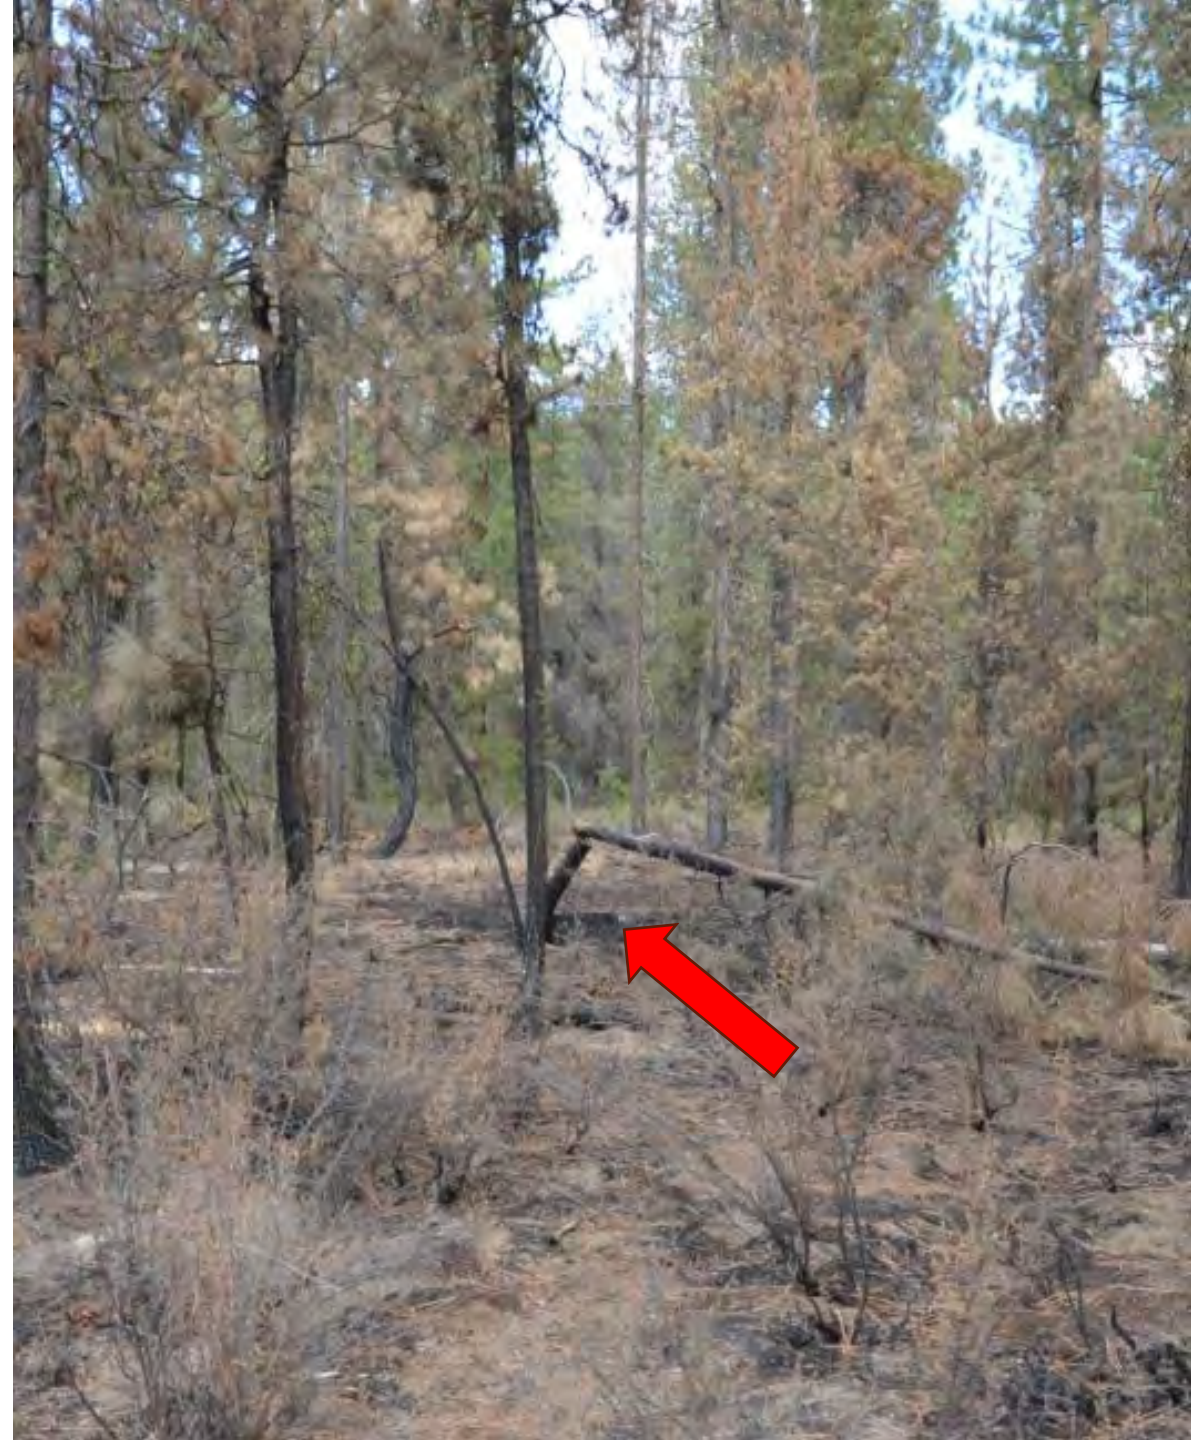
2. HIDDEN EXTERNAL CAVITIES AND OLD FIRE SCARS

Same pine: arrow indicates top of vertically attenuated old fire scar. Splintered wood represents lower end of failure fracture which occurred directly above the cavity and fire scar.

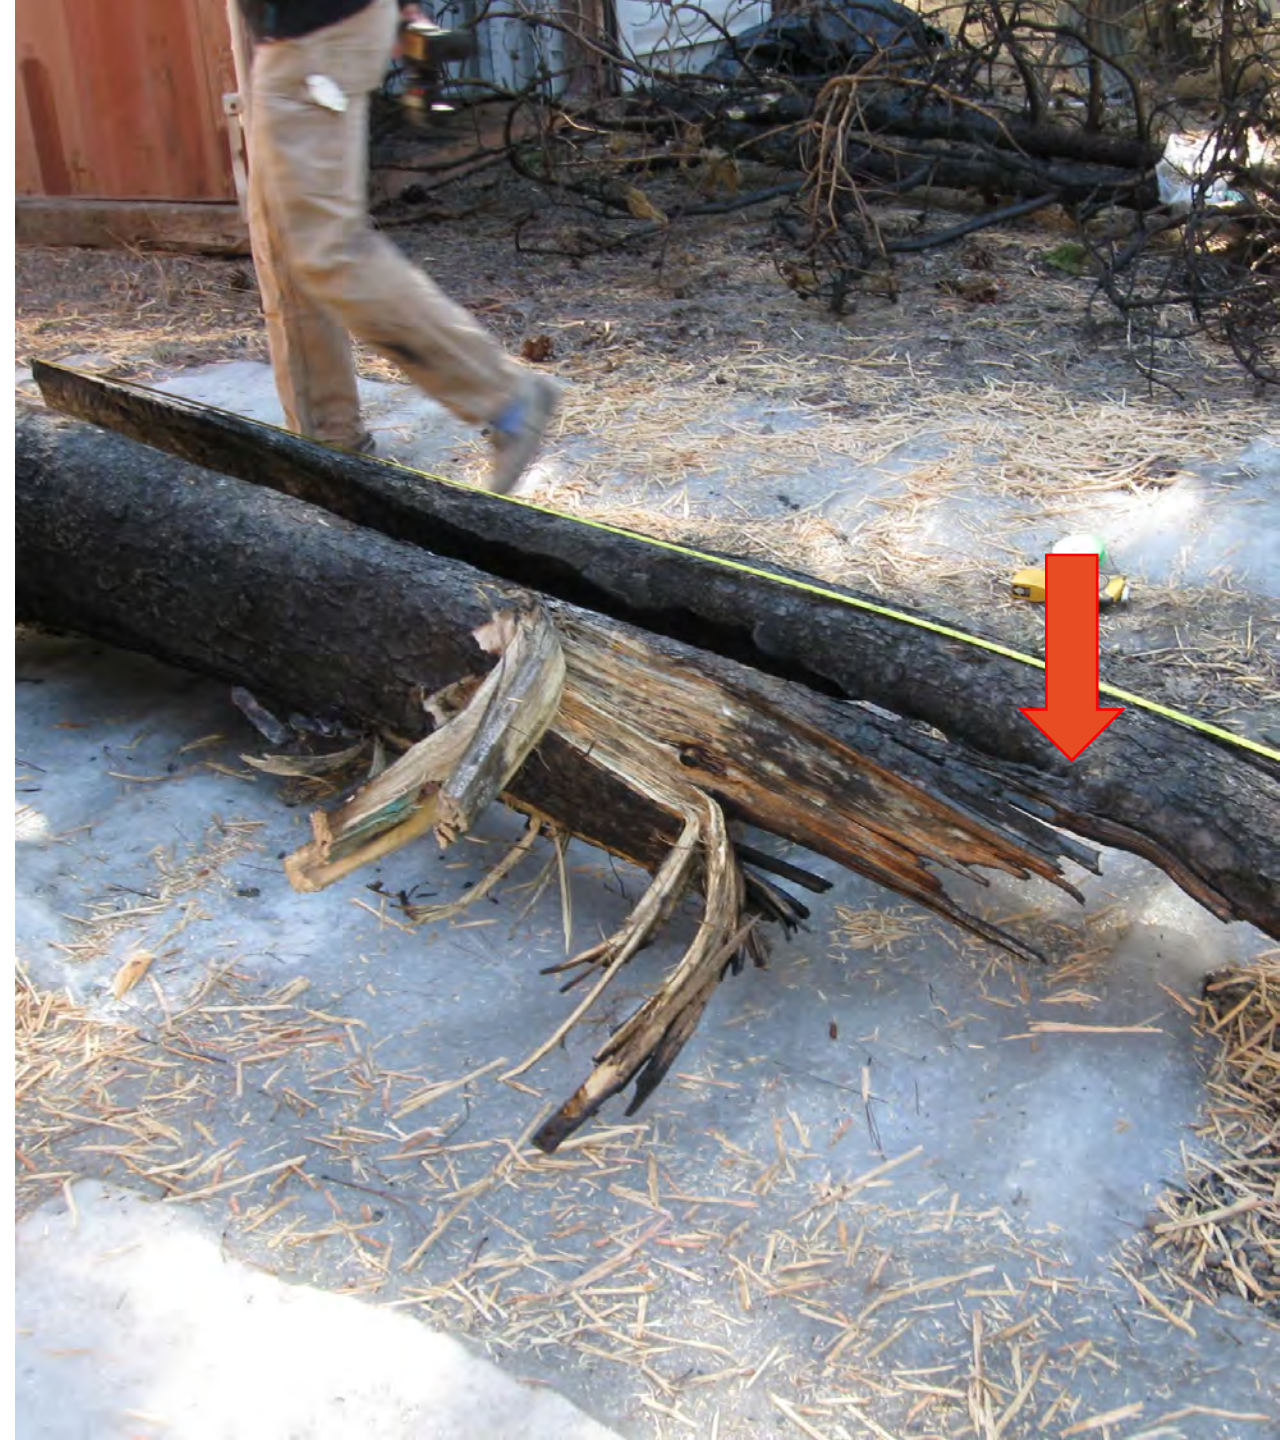
2. HIDDEN EXTERNAL CAVITIES AND OLD FIRE SCARS

Ponderosa pine leaning toward conductors, with no obvious defects as viewed from utility easement; however...

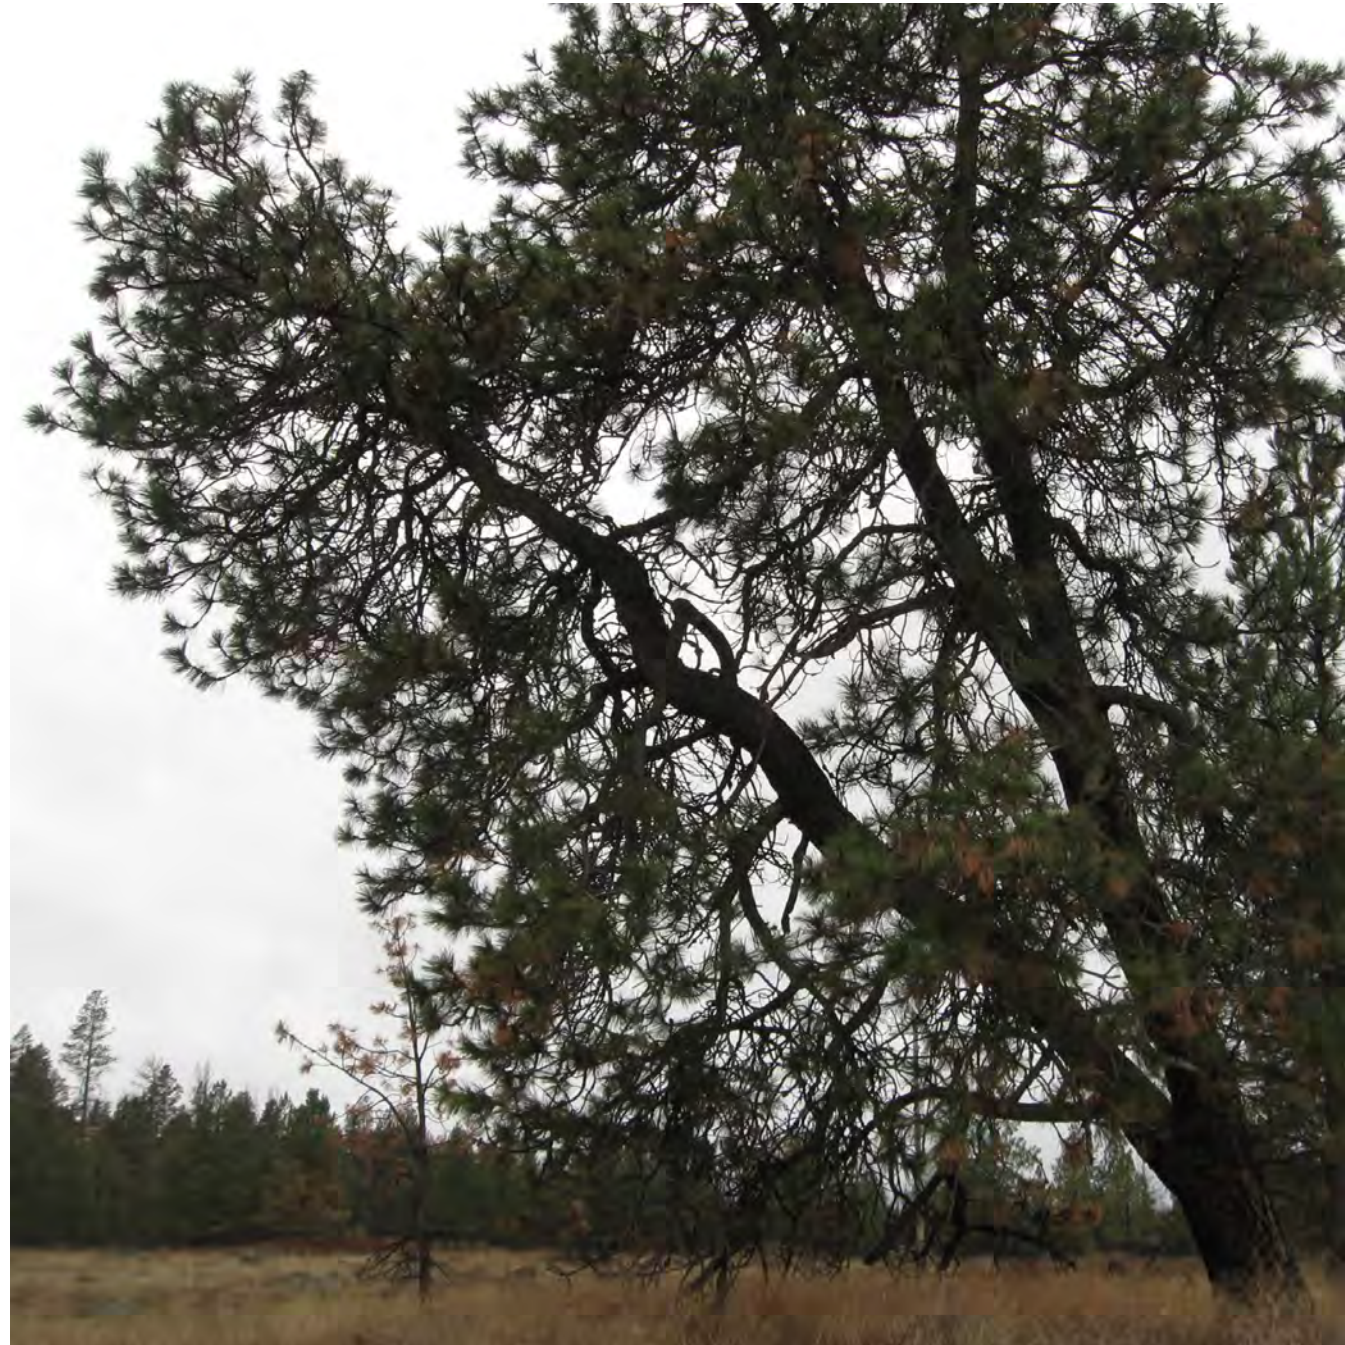
2. HIDDEN EXTERNAL CAVITIES AND OLD FIRE SCARS

The same pine with an old fire scar and open cavity with moderate to advanced wood decay. The anchor roots at grade are decayed.

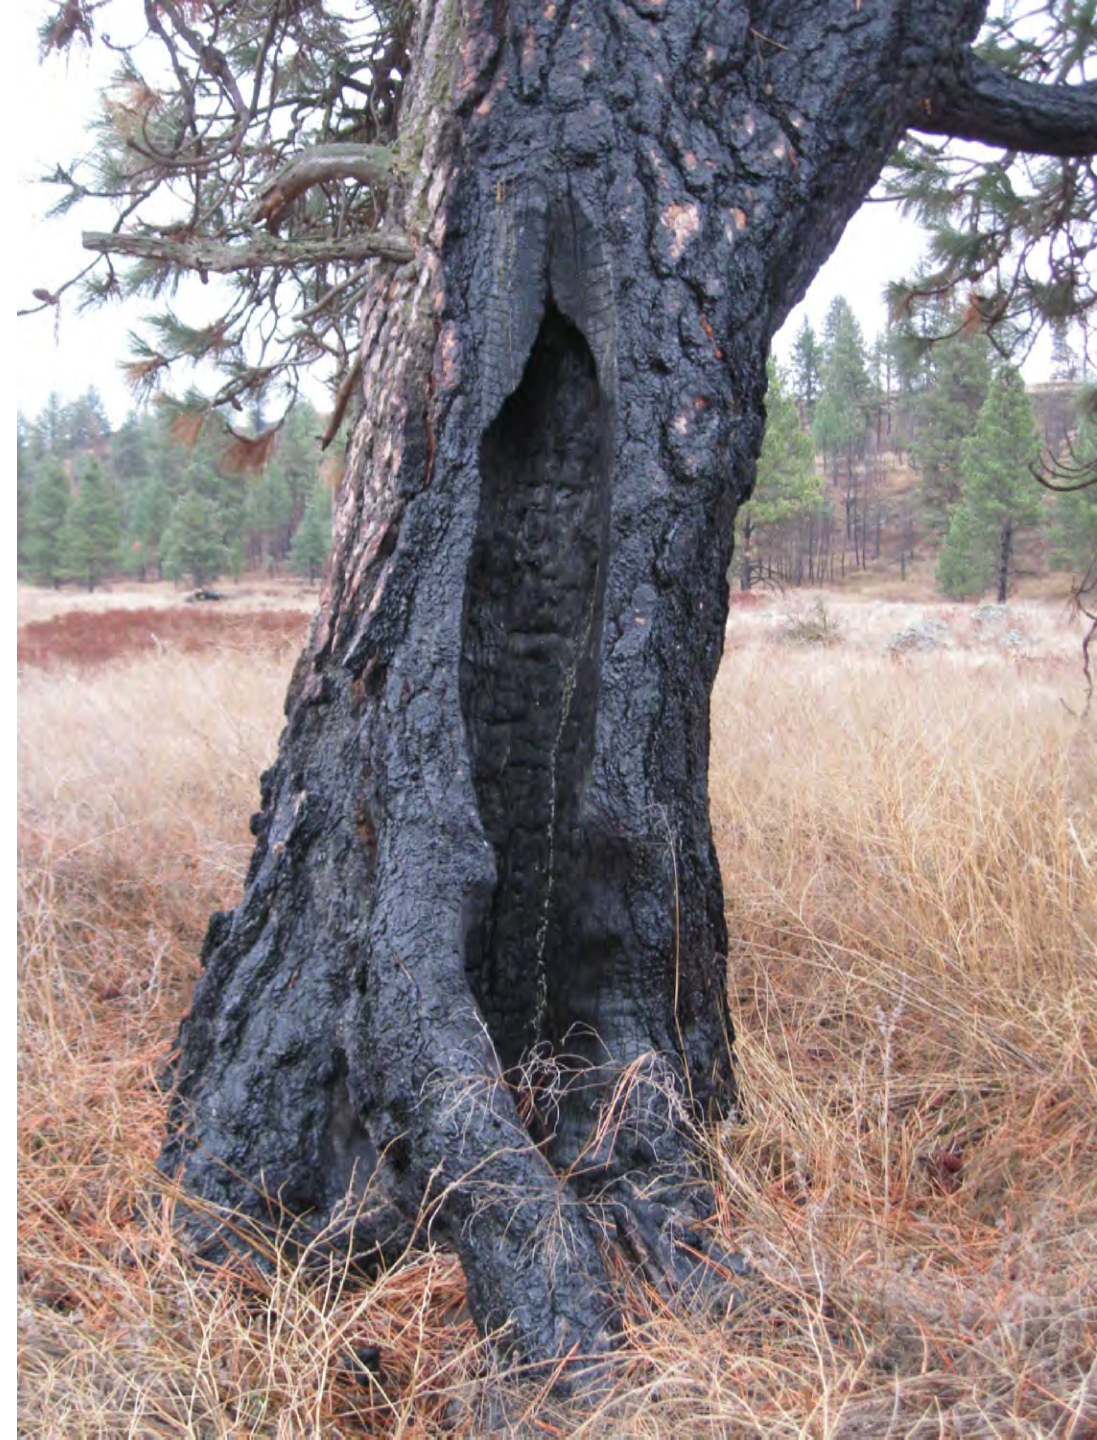
2. HIDDEN EXTERNAL CAVITIES AND OLD FIRE SCARS

Douglas-fir with multiple fire scars, and only limited internal wood decay. Arrows indicate extensive woundwood response attempting to close the original open wound.

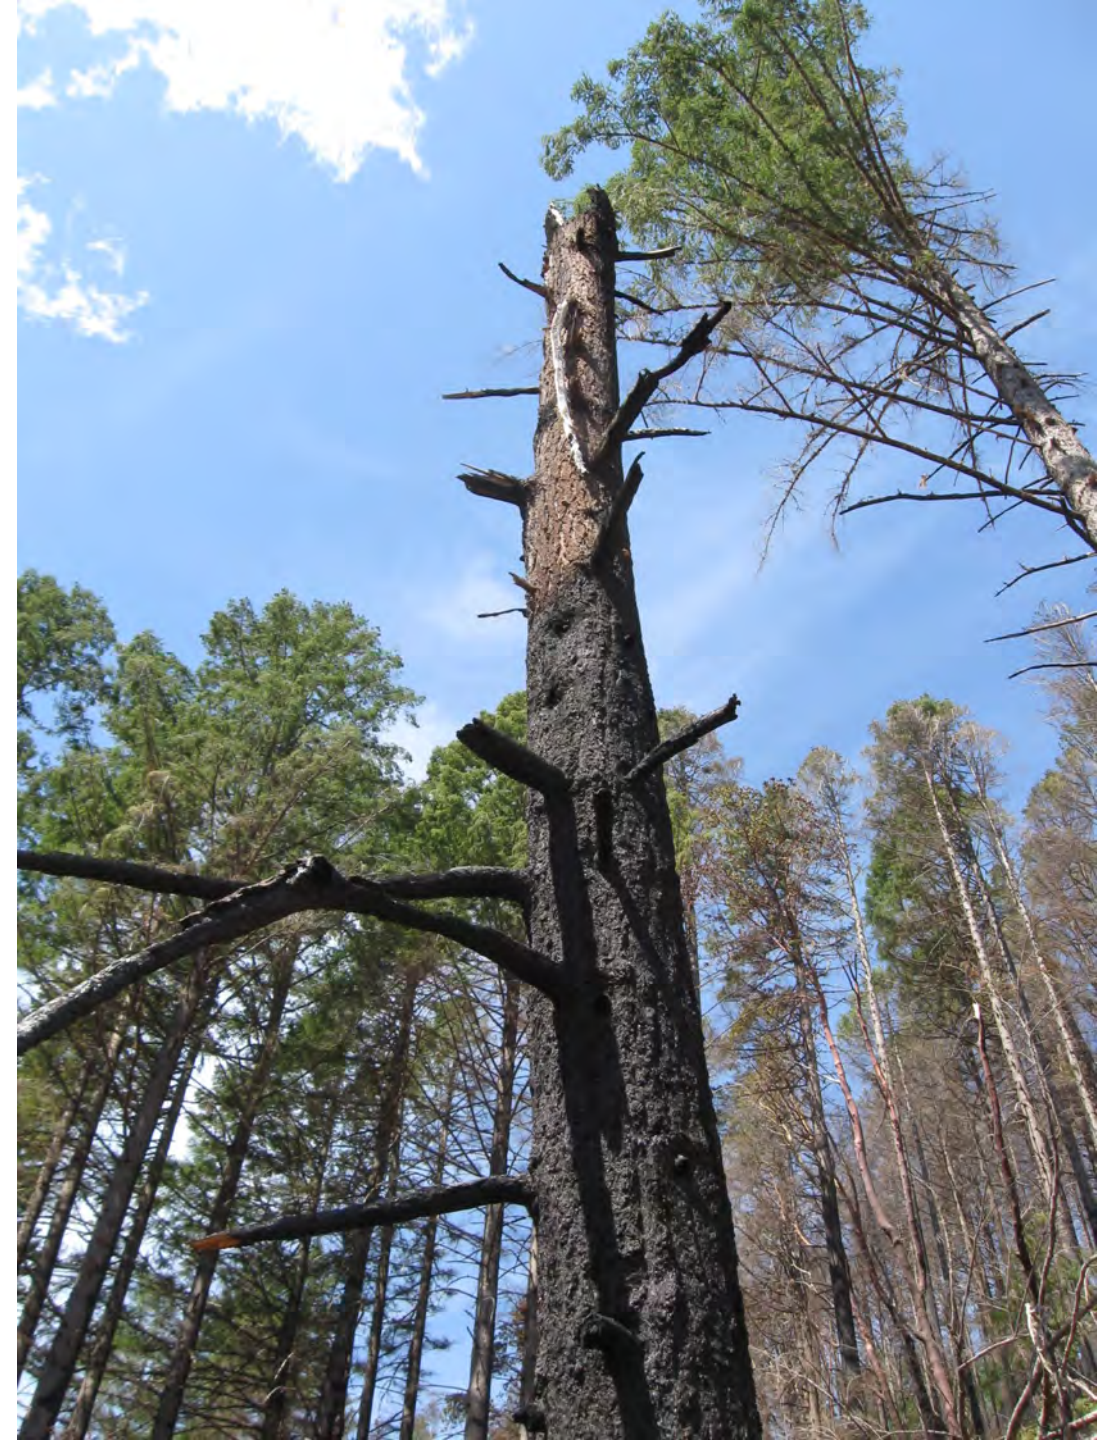
3. VISIBLE INDICATORS OF SAPWOOD DECAY

Same Douglas-fir showing signs of serious sapwood decay, with pouch-like fungal fruiting bodies protruding through the bark.

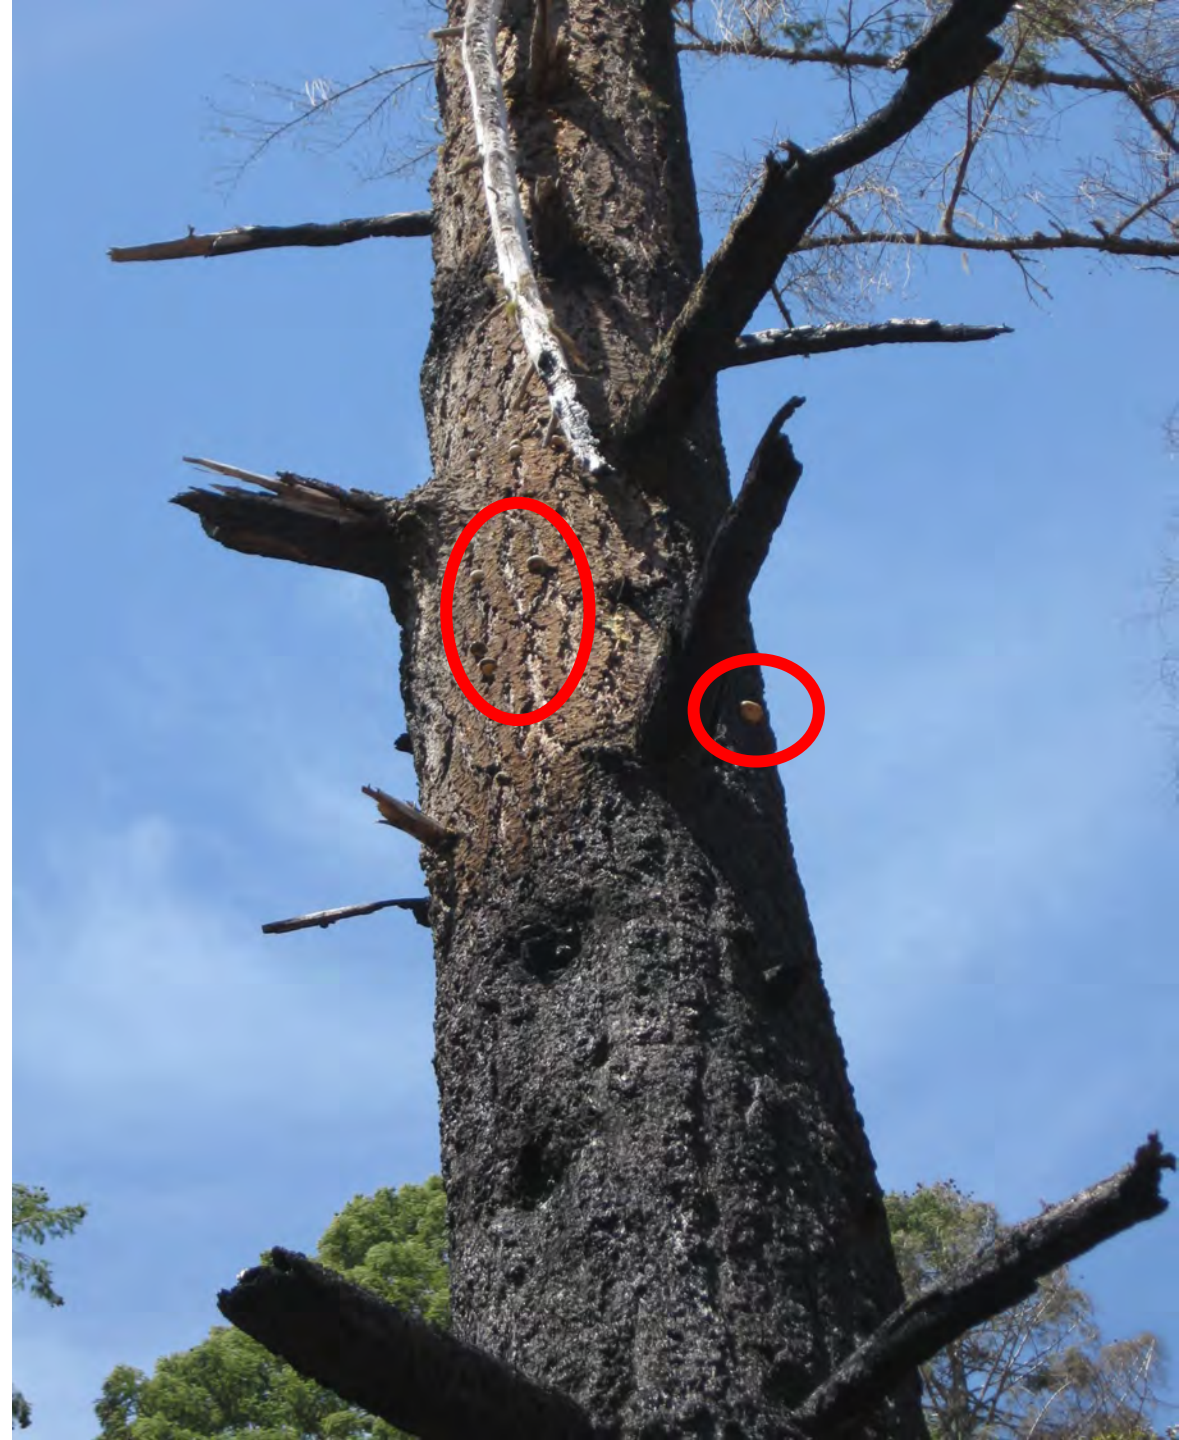
3. VISIBLE INDICATORS OF SAPWOOD DECAY

Punk knots extending from the inner wood to the outside of the bark. These are fruiting bodies of advanced sapwood decay fungi, and can mimic branch stubs.

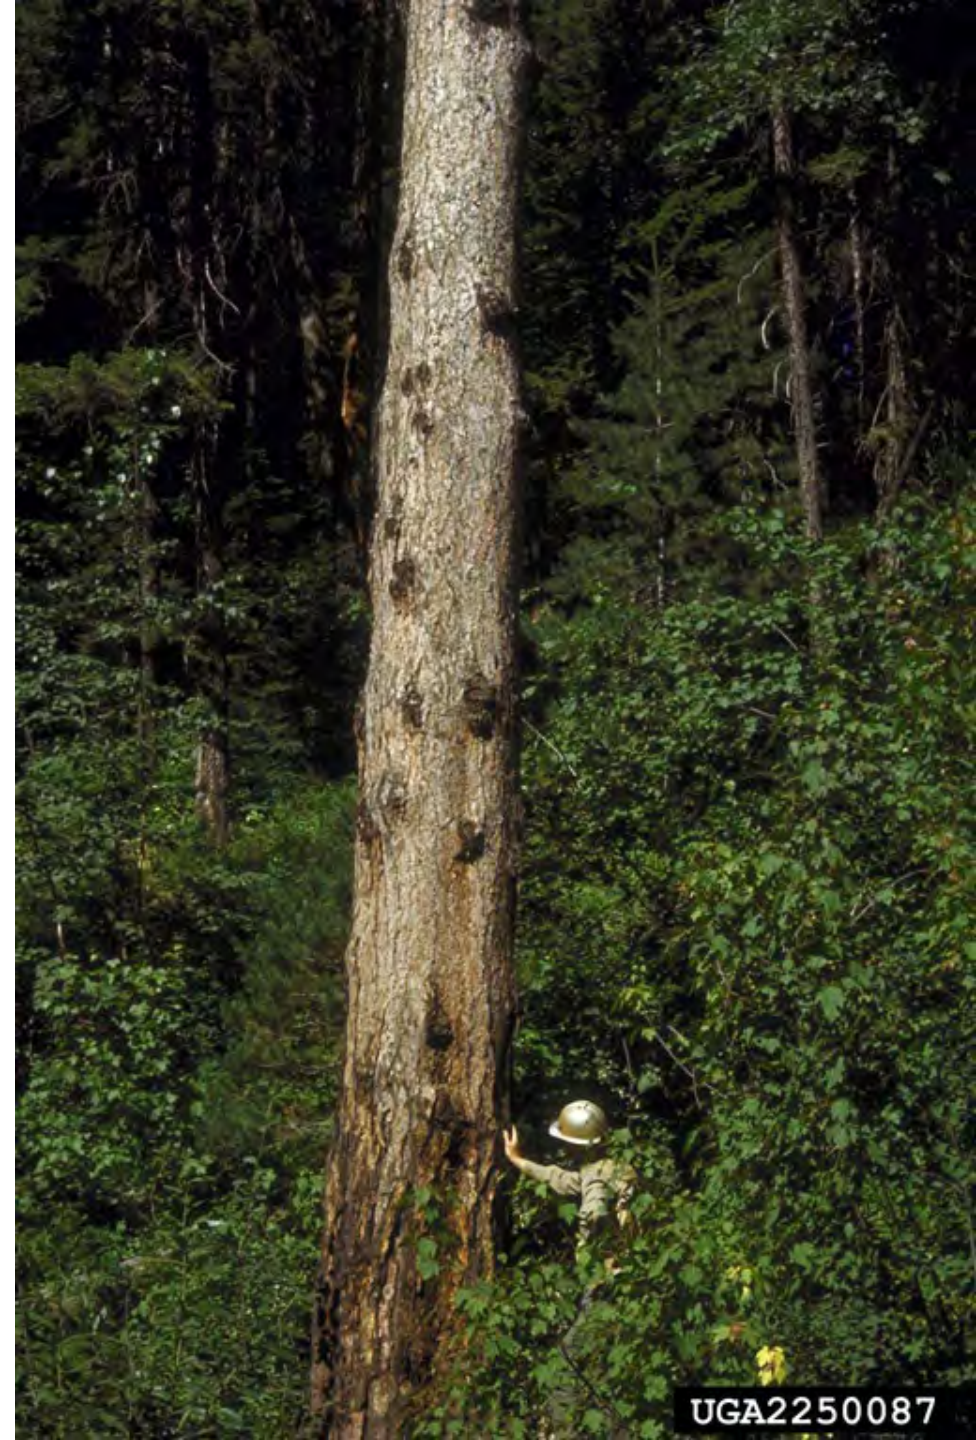
3. VISIBLE INDICATORS OF SAPWOOD DECAY

Conks or shelf-like fruiting bodies of fungi causing serious decay of trunk wood.
