Transmission Division

Method for repairing OPGW in proximity to energized conductors

The objective of this work is to present a procedure for the repair of a damaged OPGW conductor, in the proximity of energized transmission lines of 138 kV or higher.

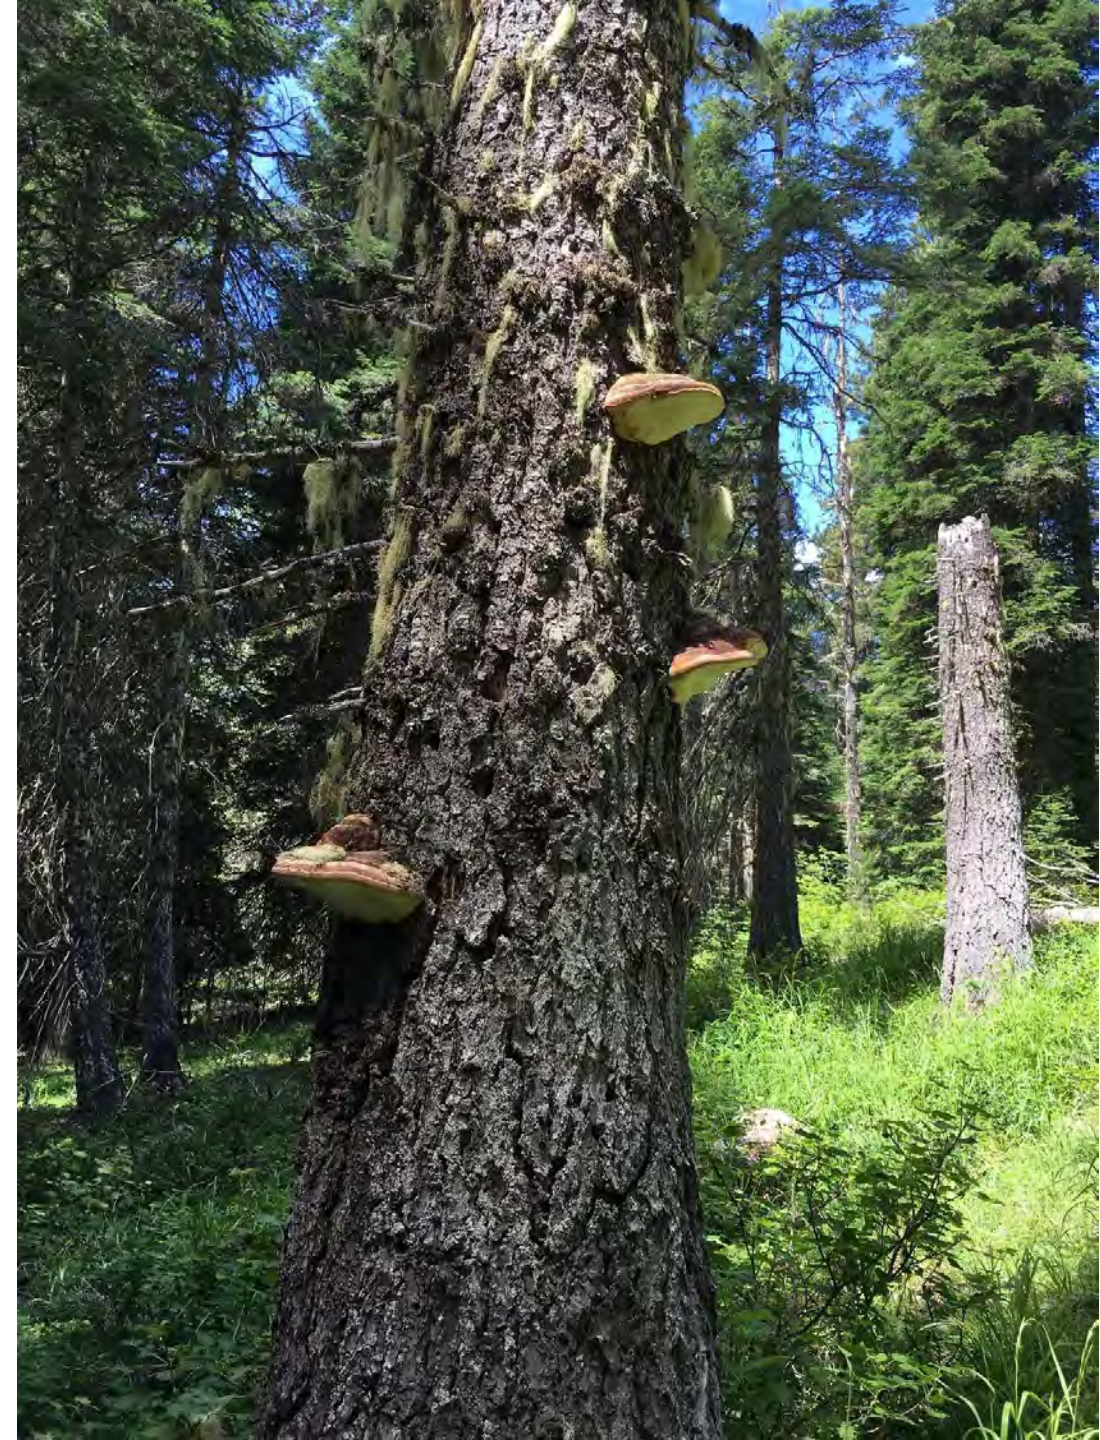
3. VISIBLE INDICATORS OF SAPWOOD DECAY

Only present during autumn, these ‘honey-cap’ mushrooms indicate very serious decay of the lower trunk and root flare sapwood. These mushrooms do not grow on the trunk.

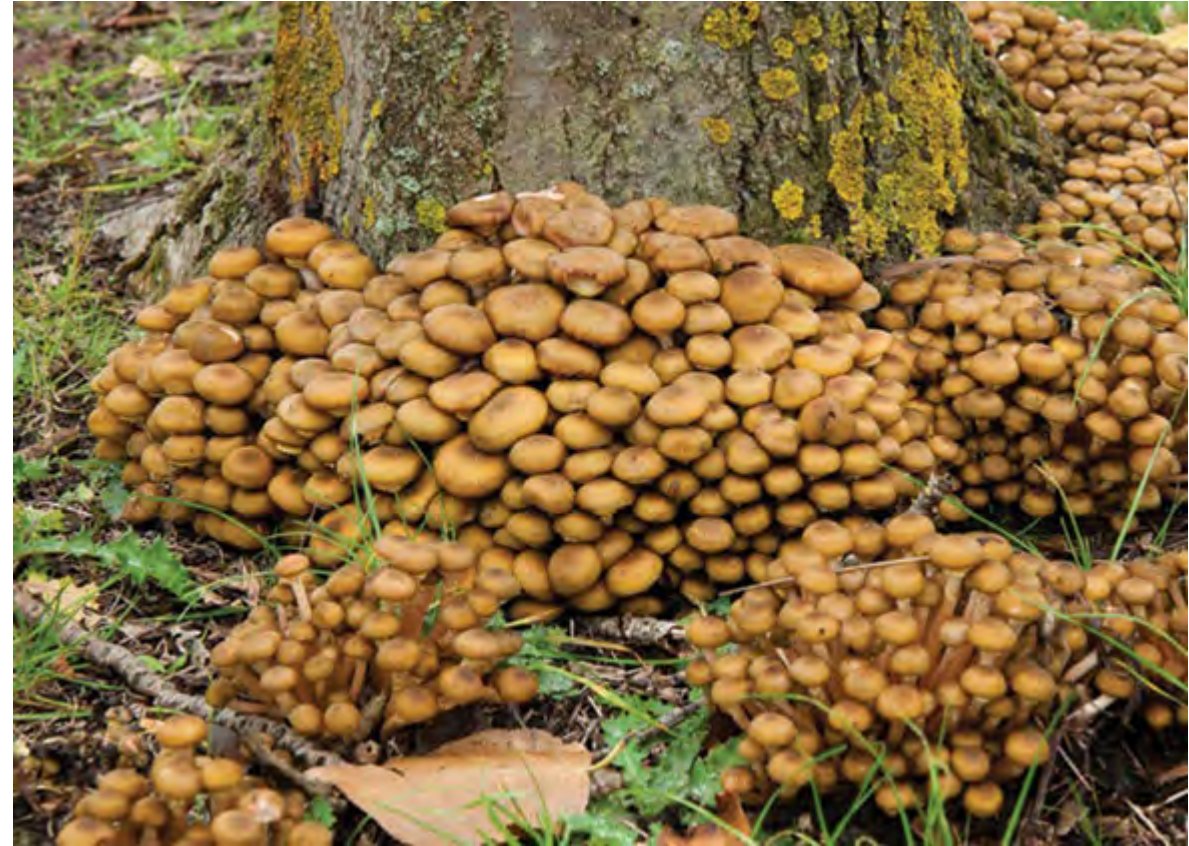
3. VISIBLE INDICATORS OF SAPWOOD DECAY

Yellowish-white nodules on the bark of many tree species represent the beginning stages of fungal fruiting bodies that indicate serious sapwood decay.

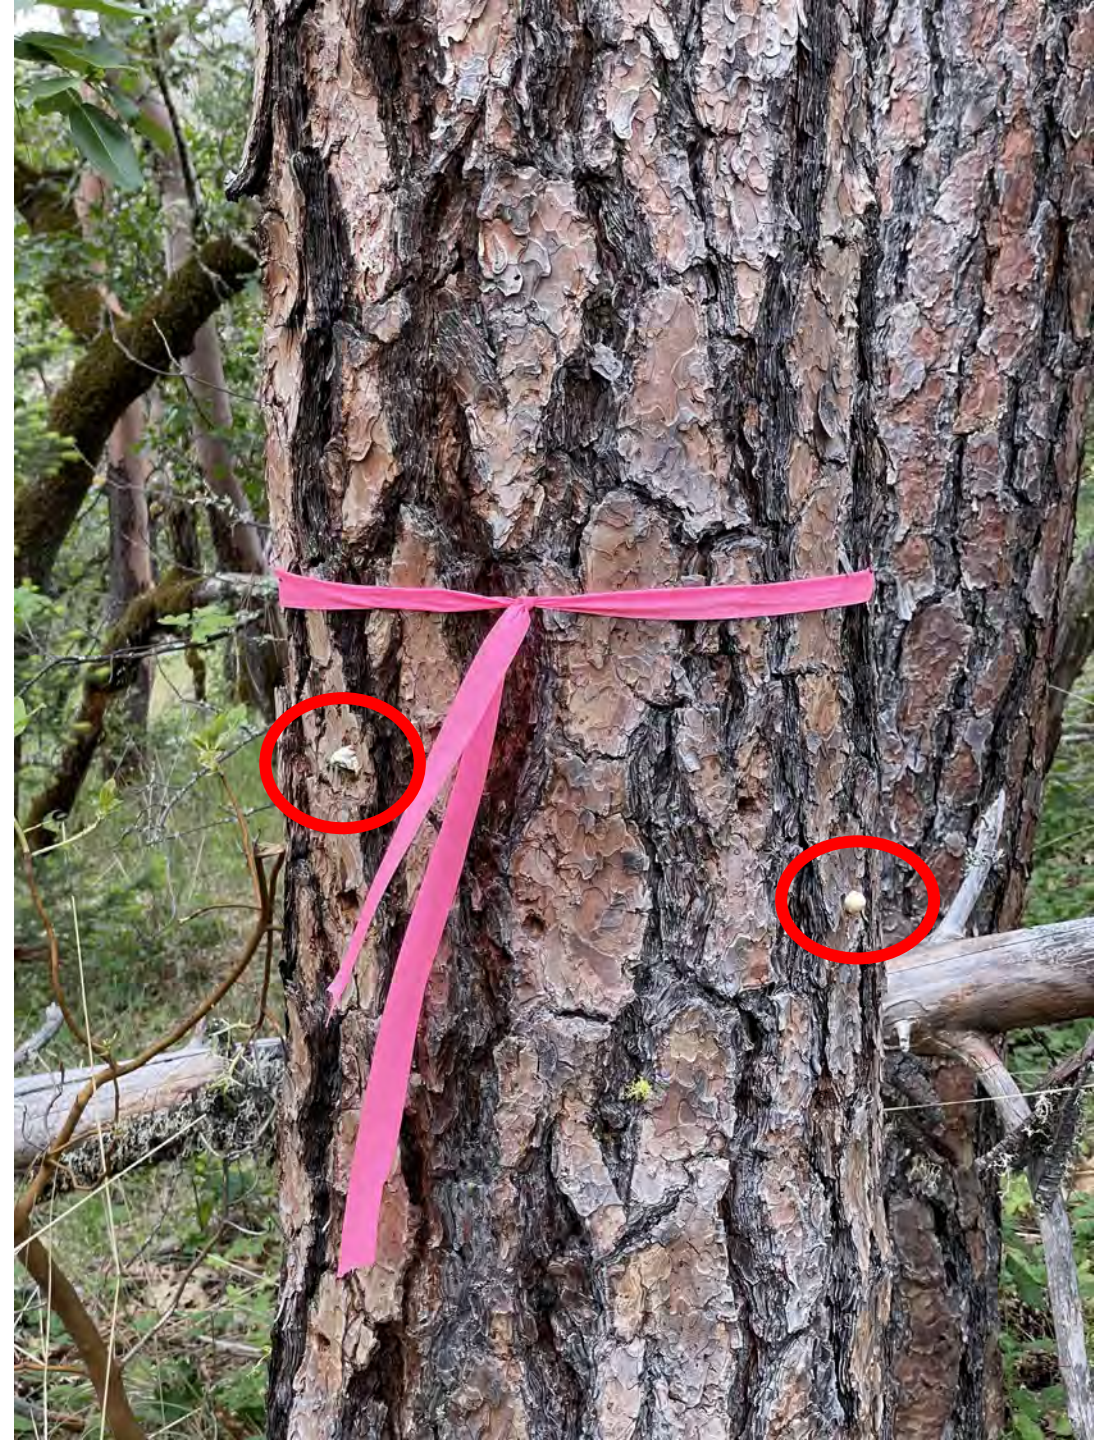
4. OBSCURE ROOT AND BUTT ROT

230' tall Douglas-fir prior to its total and catastrophic failure onto an adjacent road.
Cause: root and butt rot + gravity. Utilities are underground in this area.

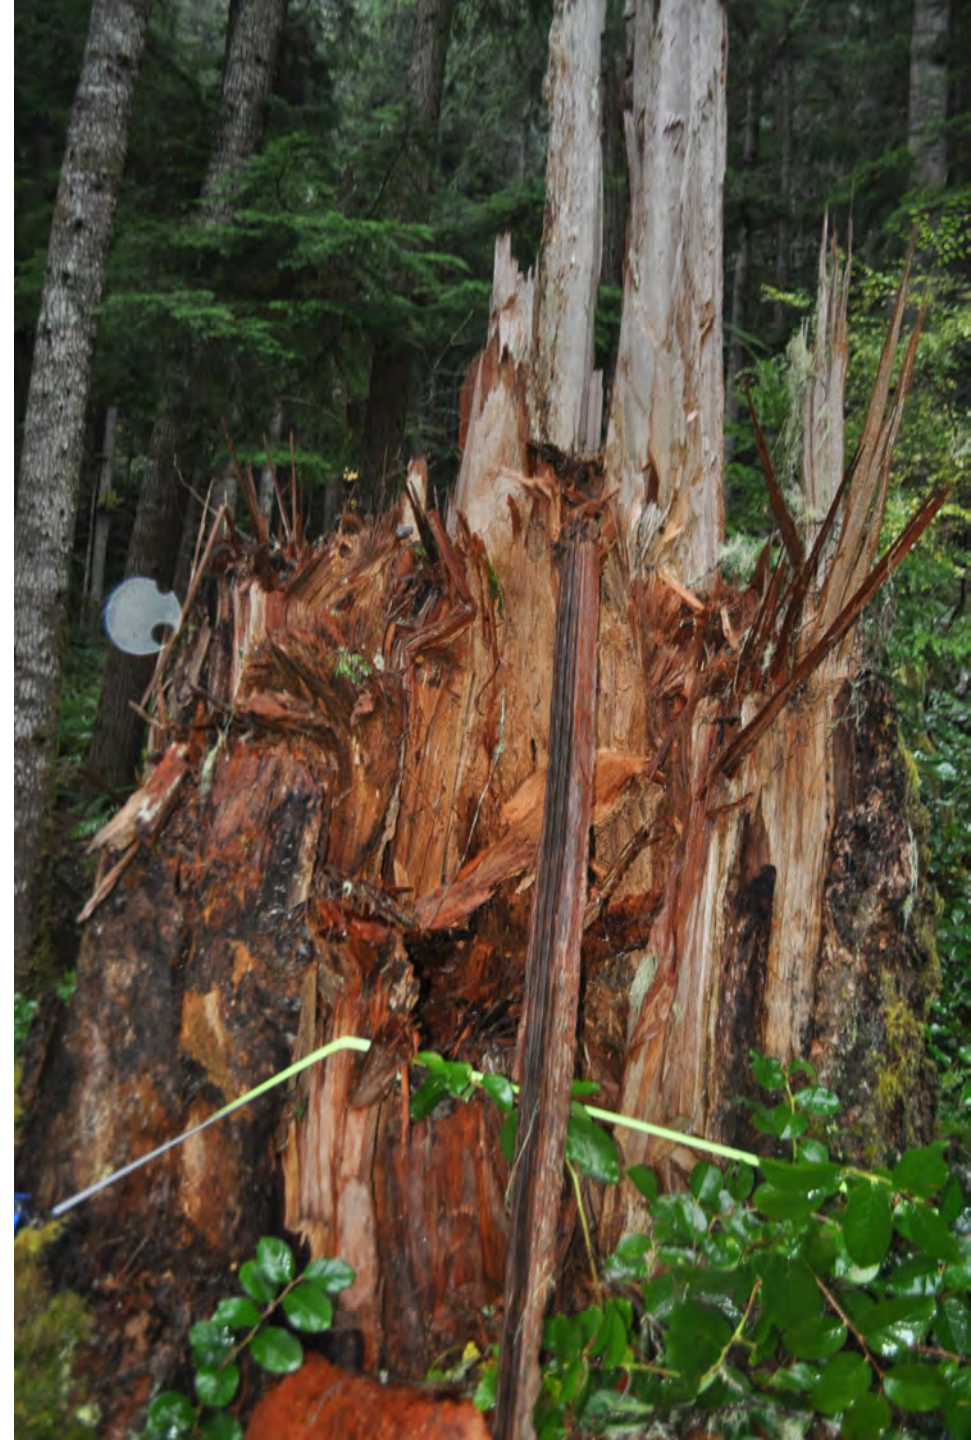
4. OBSCURE ROOT AND BUTT ROT

Same tree, showing delamination effect of advanced root decay caused by laminated root rot. The wood is spongy and structurally unsound.

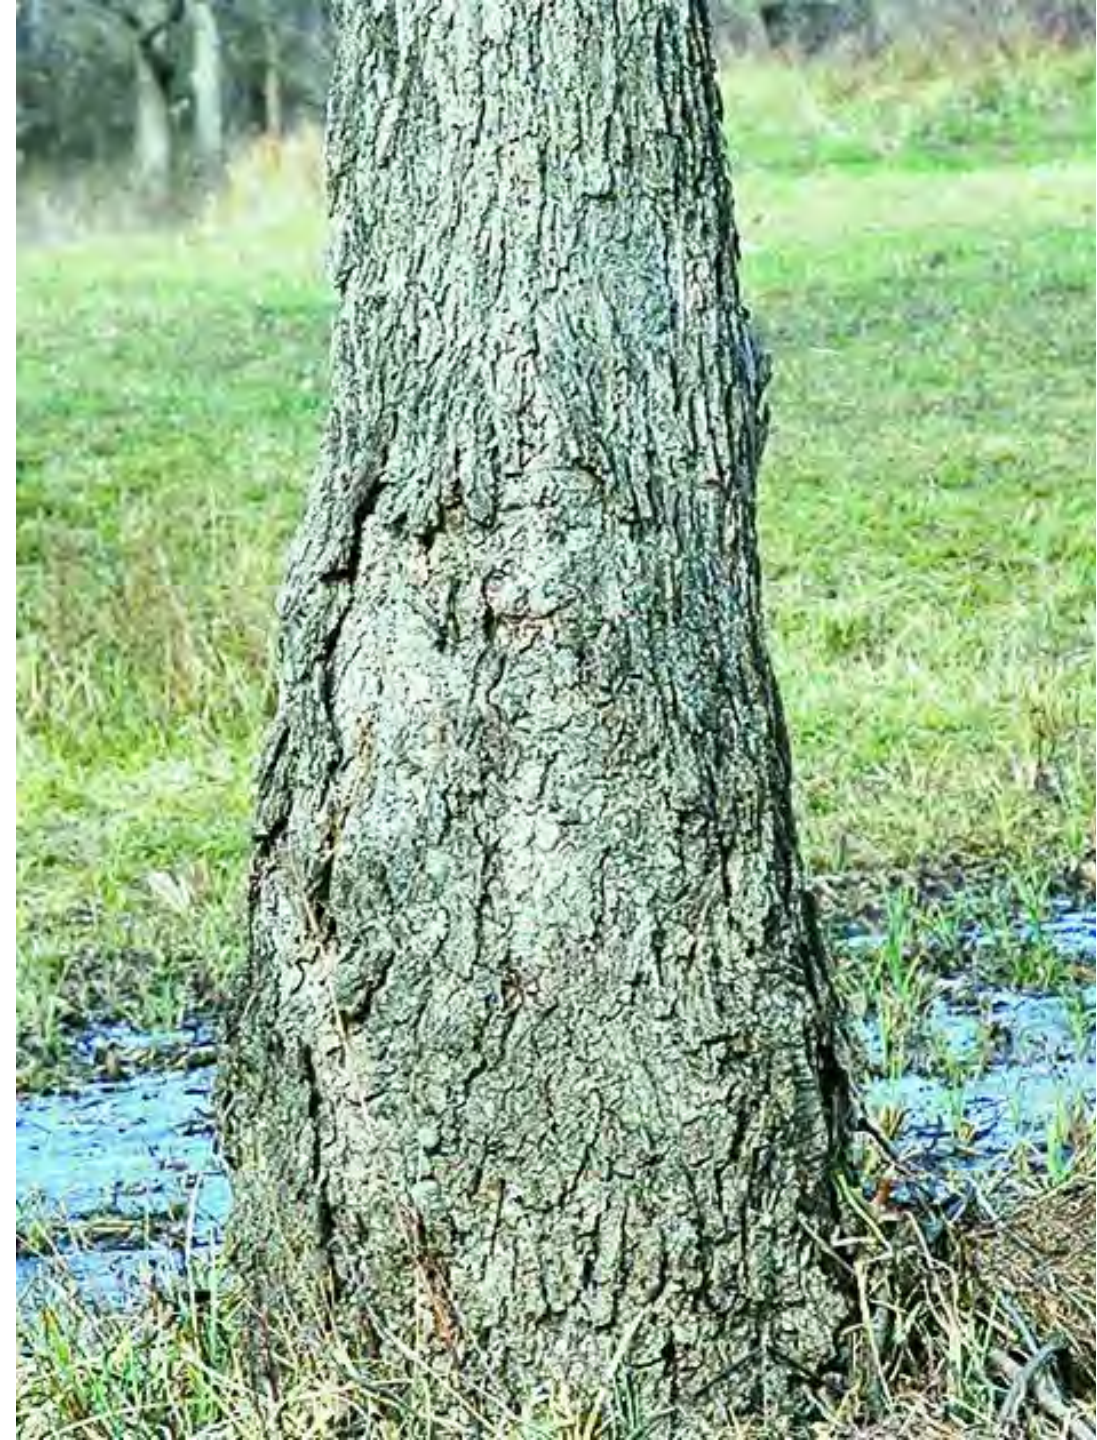
4. OBSCURE ROOT AND BUTT ROT

In the absence of these ephemeral fruiting bodies, the obscure root and butt rot of affected trees often goes unnoticed to the untrained eye.

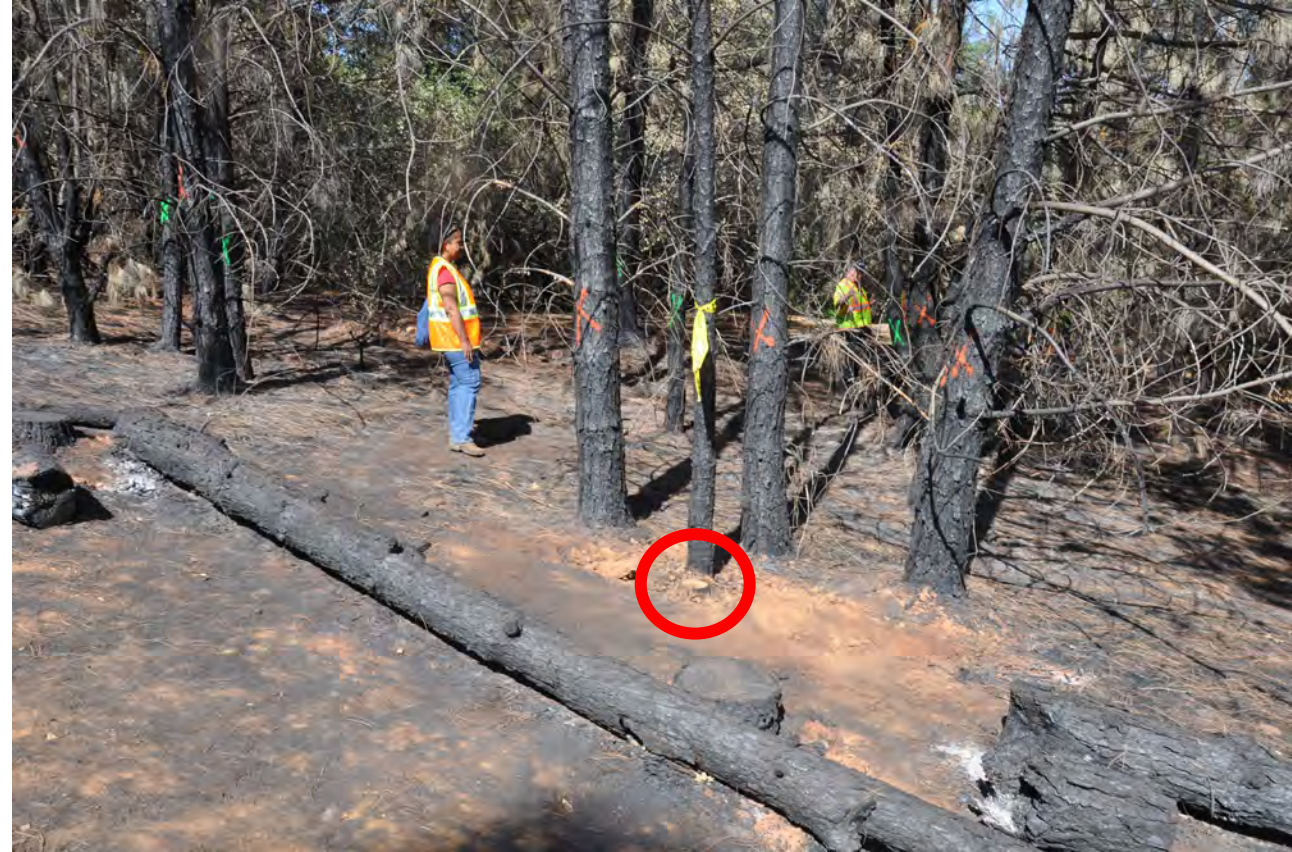
5. ARTIFICIALLY
SUPPORTED AND WEAK
TREES RELEASED BY
NATURAL AND HUMAN
EVENTS

A gray pine immediately adjacent to the failed pine in the prior slide is shown here being artificially supported by other trees.

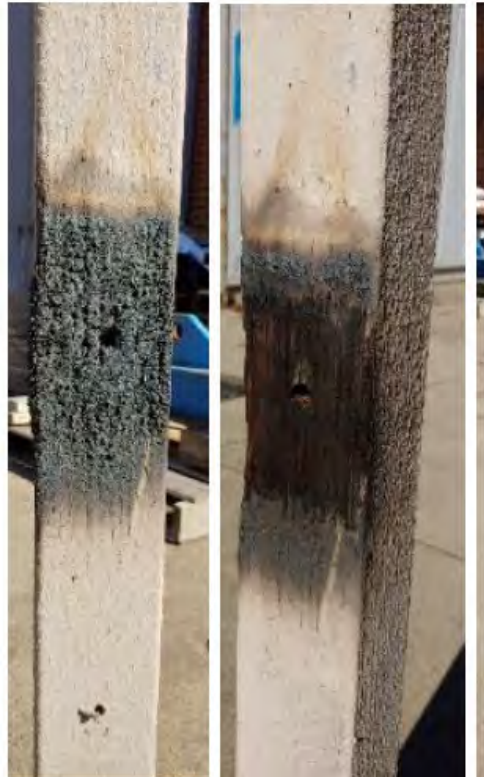
Coatings

- Wraps/meshes
- Intumescent coatings
- Foams, spray on products

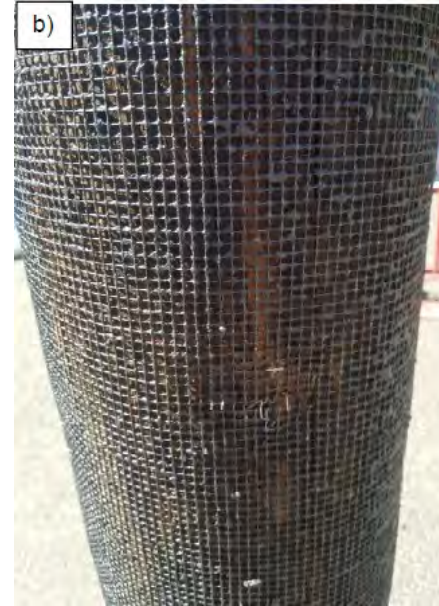
Genics mesh wraps

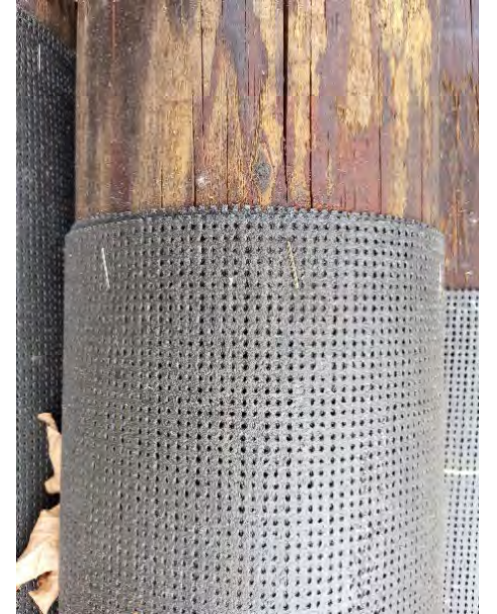
Hexion Armorbuilt wraps

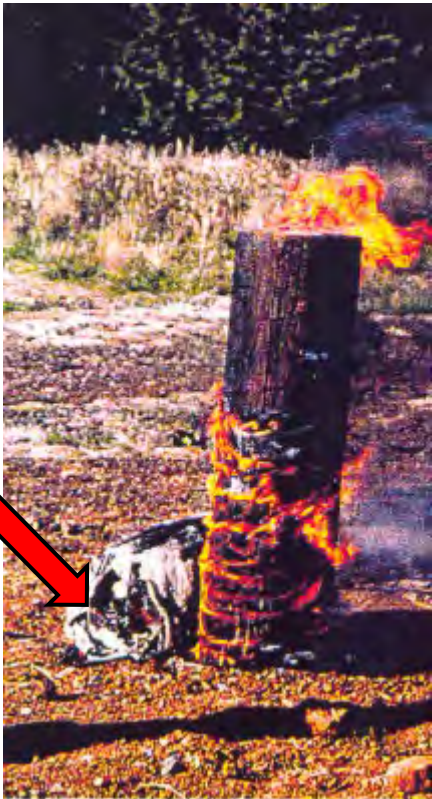
UPRC 1999 Annual Report

Straw bag
for fuel

- OSU Utility Pole Research Cooperative developed testing methods over two decades

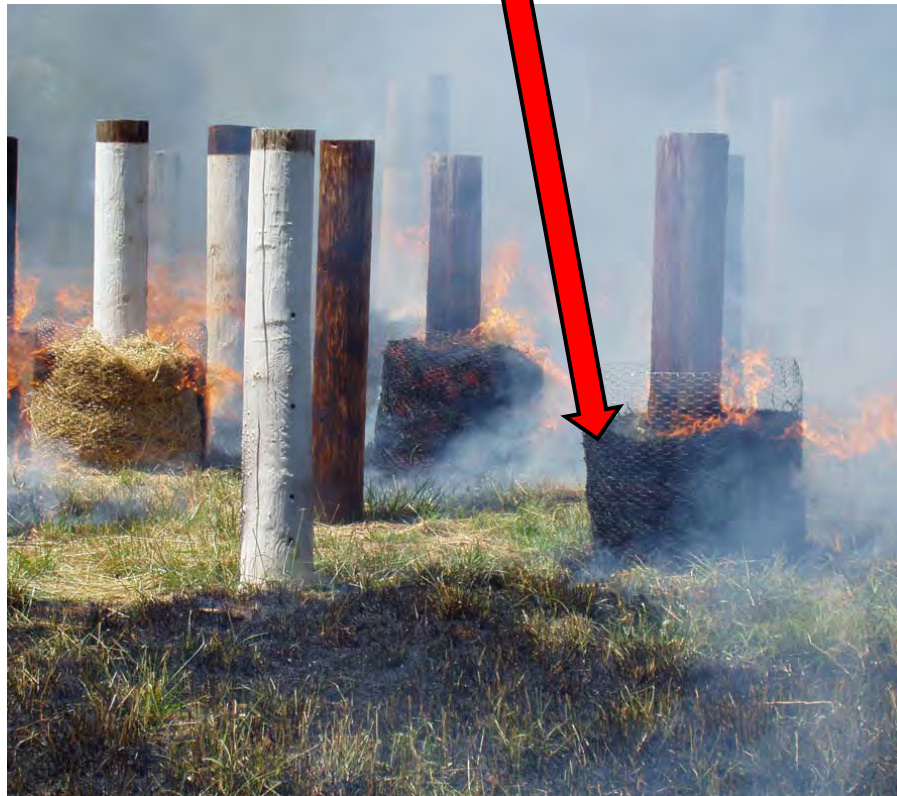
UPRC 2006 Annual Report

Straw bale in
wire mesh

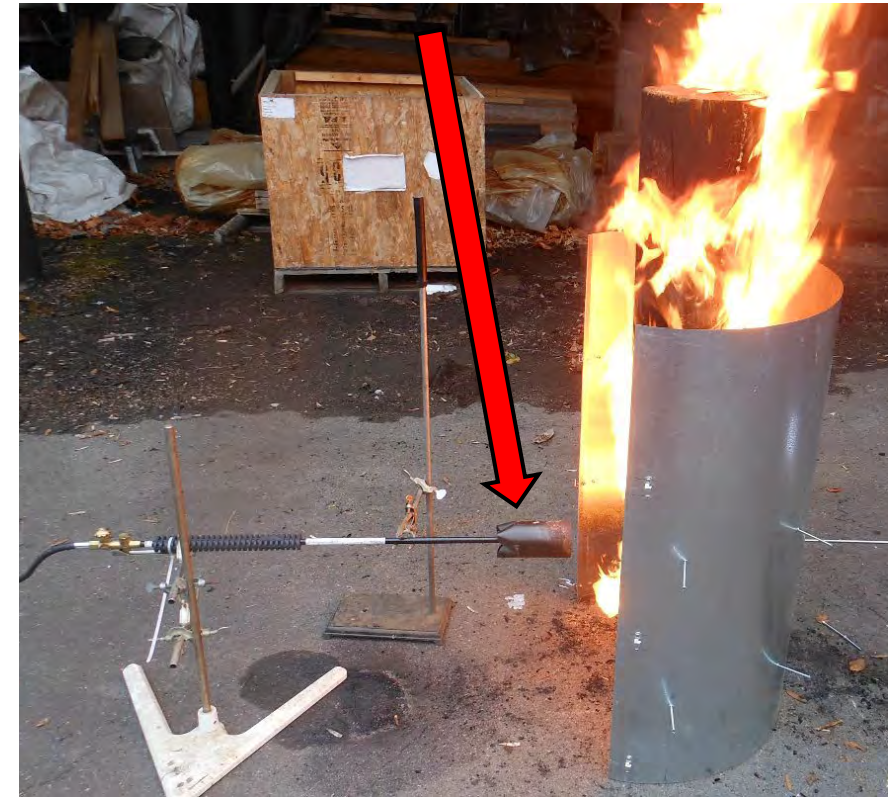
UPRC 2014 Annual Report

Weed Burner

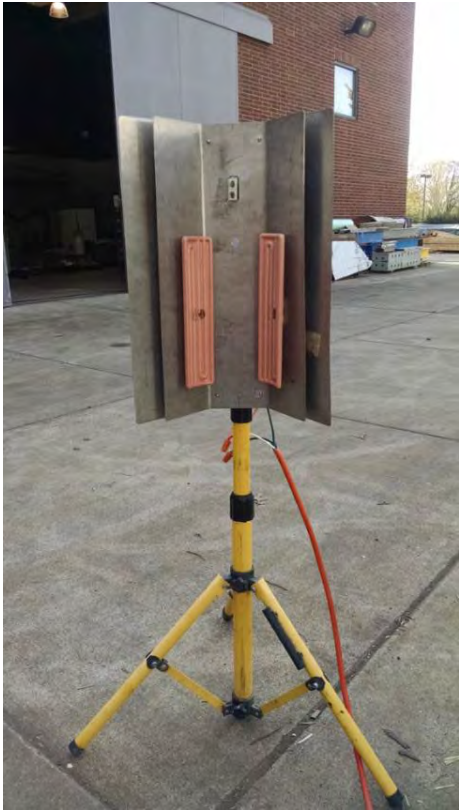
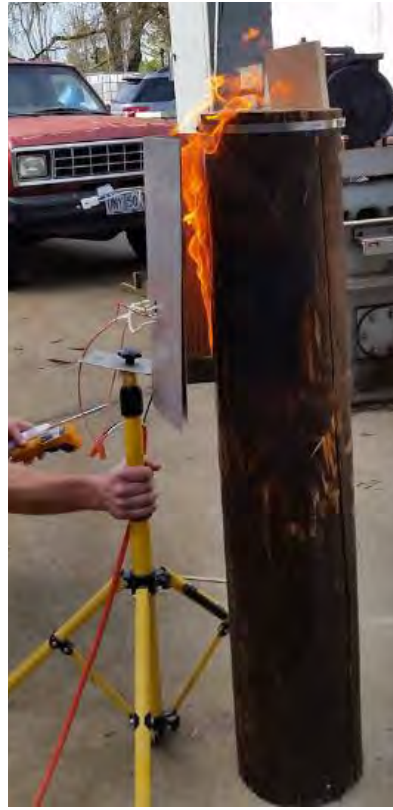
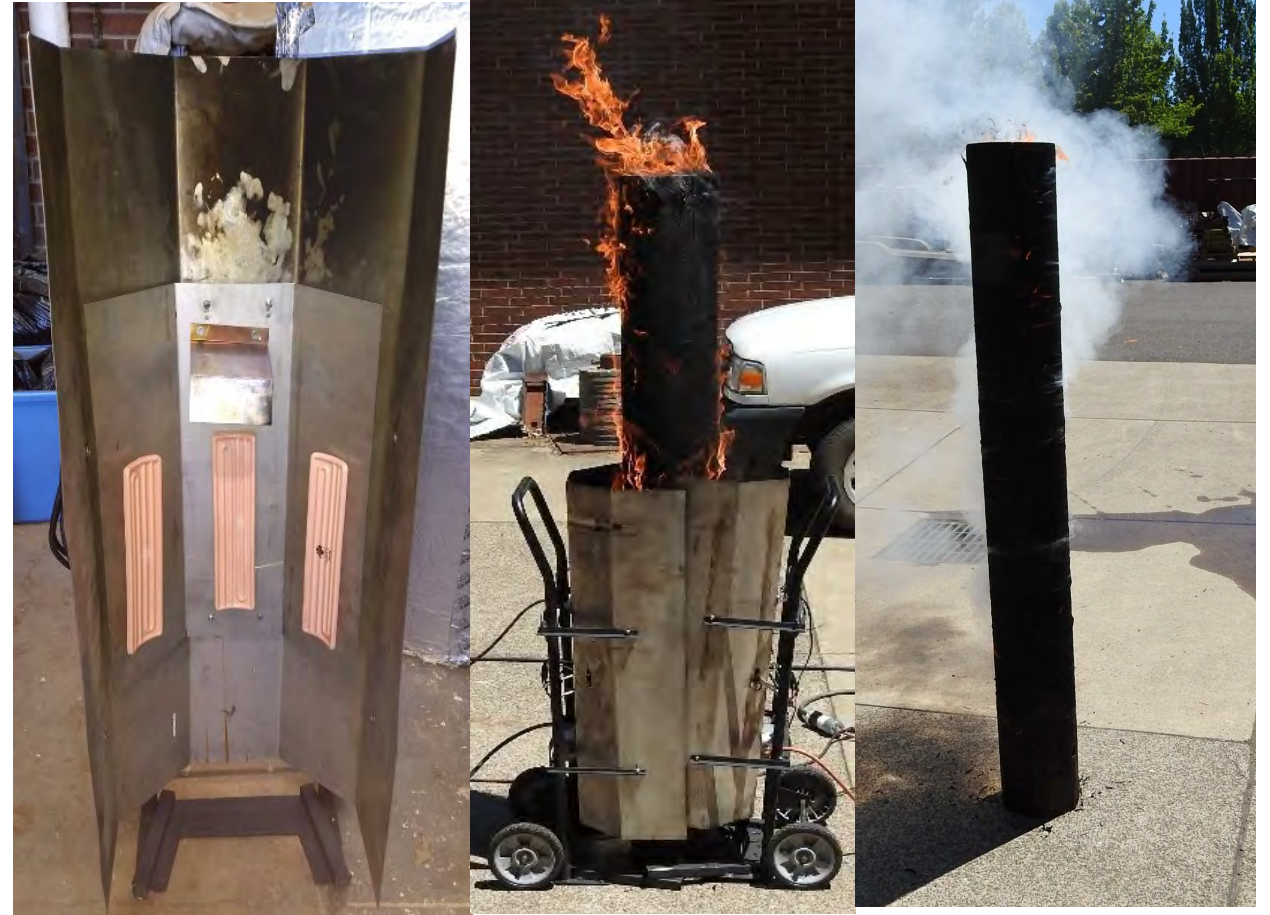
Heat Panel-Based Fire Testing Apparatus

- Small scale fire test- Built by Milo Clausen
- Relatively uniform heat application
- Reproducible conditions vs. open flame

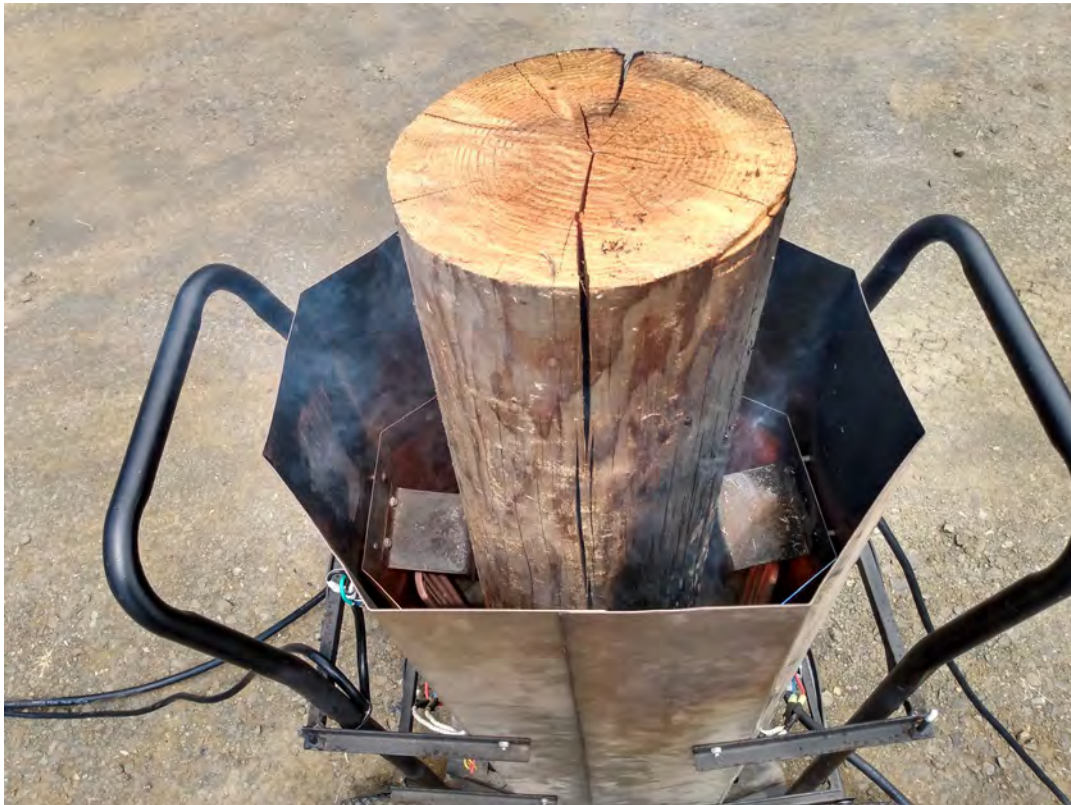
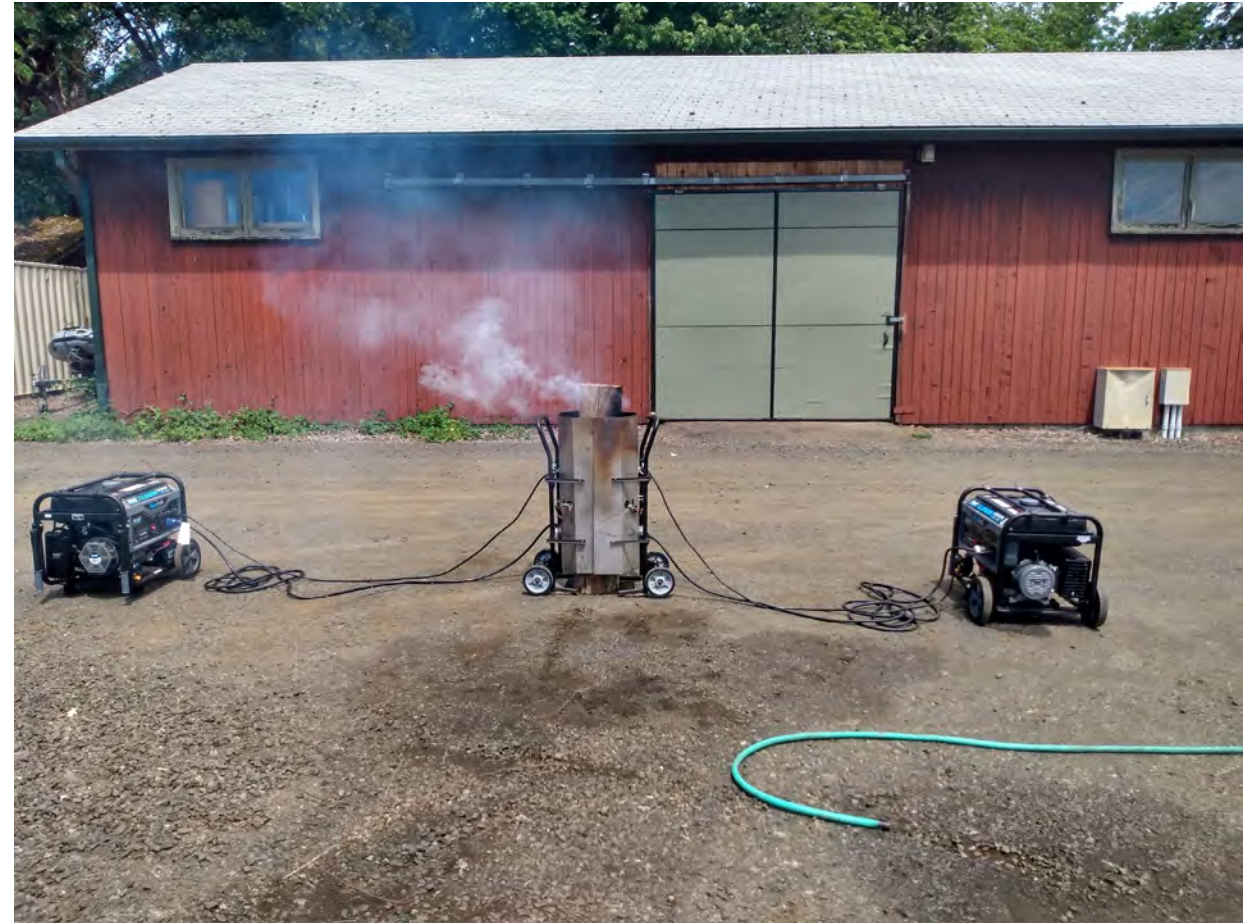
Recent Test Modifications

Remote operation on Generators

- Generators now used as power source
- Surface temps up to $\sim 700^{\circ}\text{C}$ in 6 minutes for untreated wood

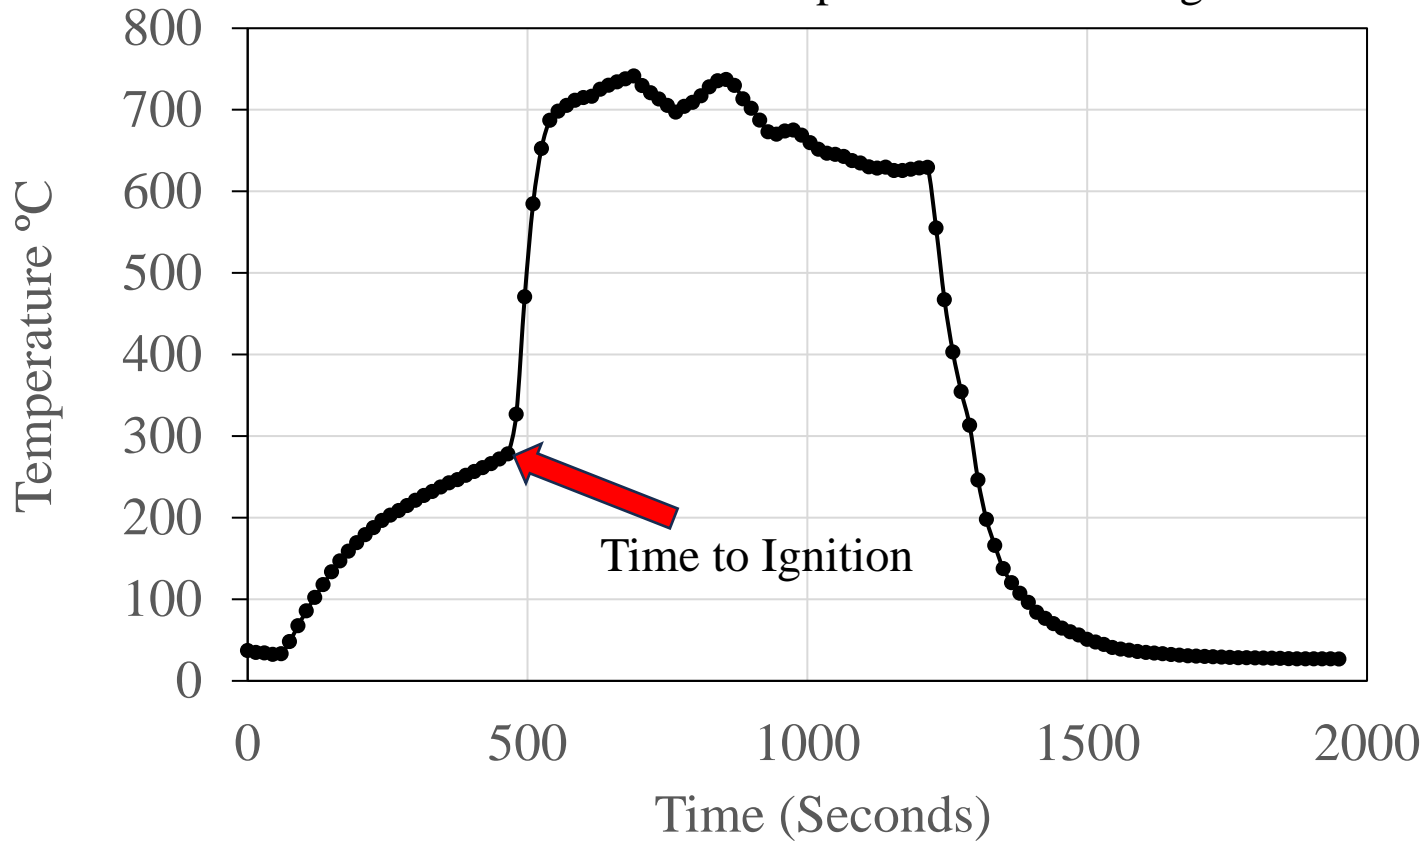
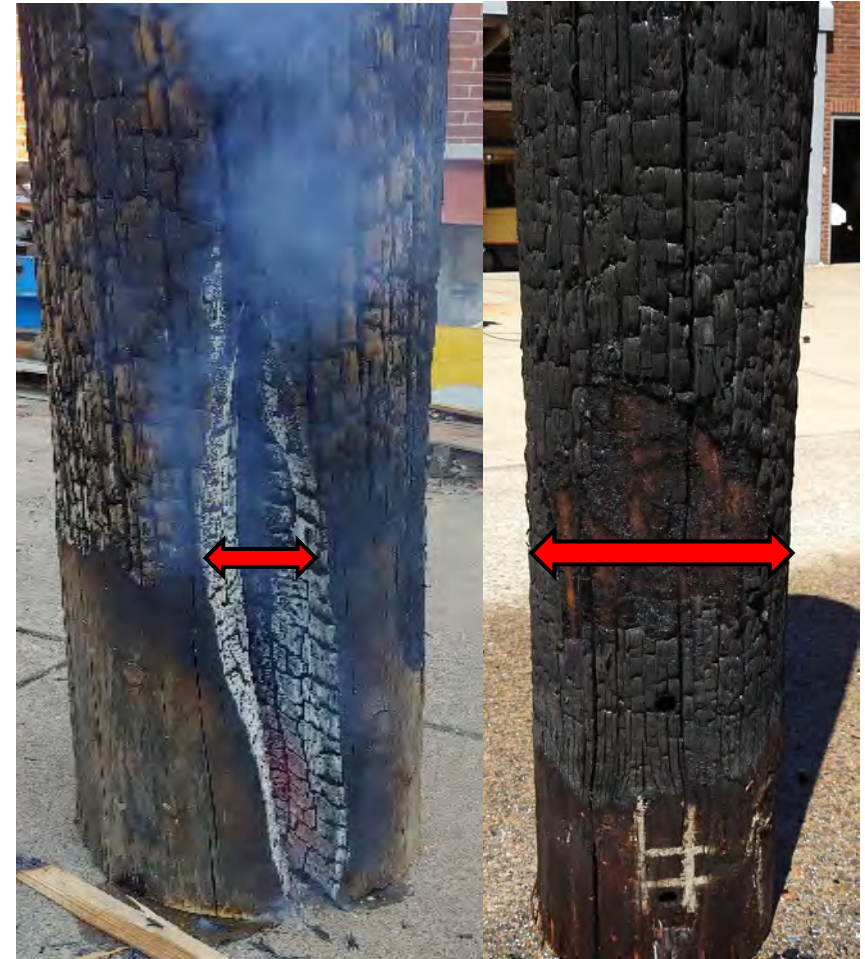
Continuous Surface Temperature Monitoring

- Several performance parameters can compare treatment performance

Check Widening

Circumference Loss
and Char Depth

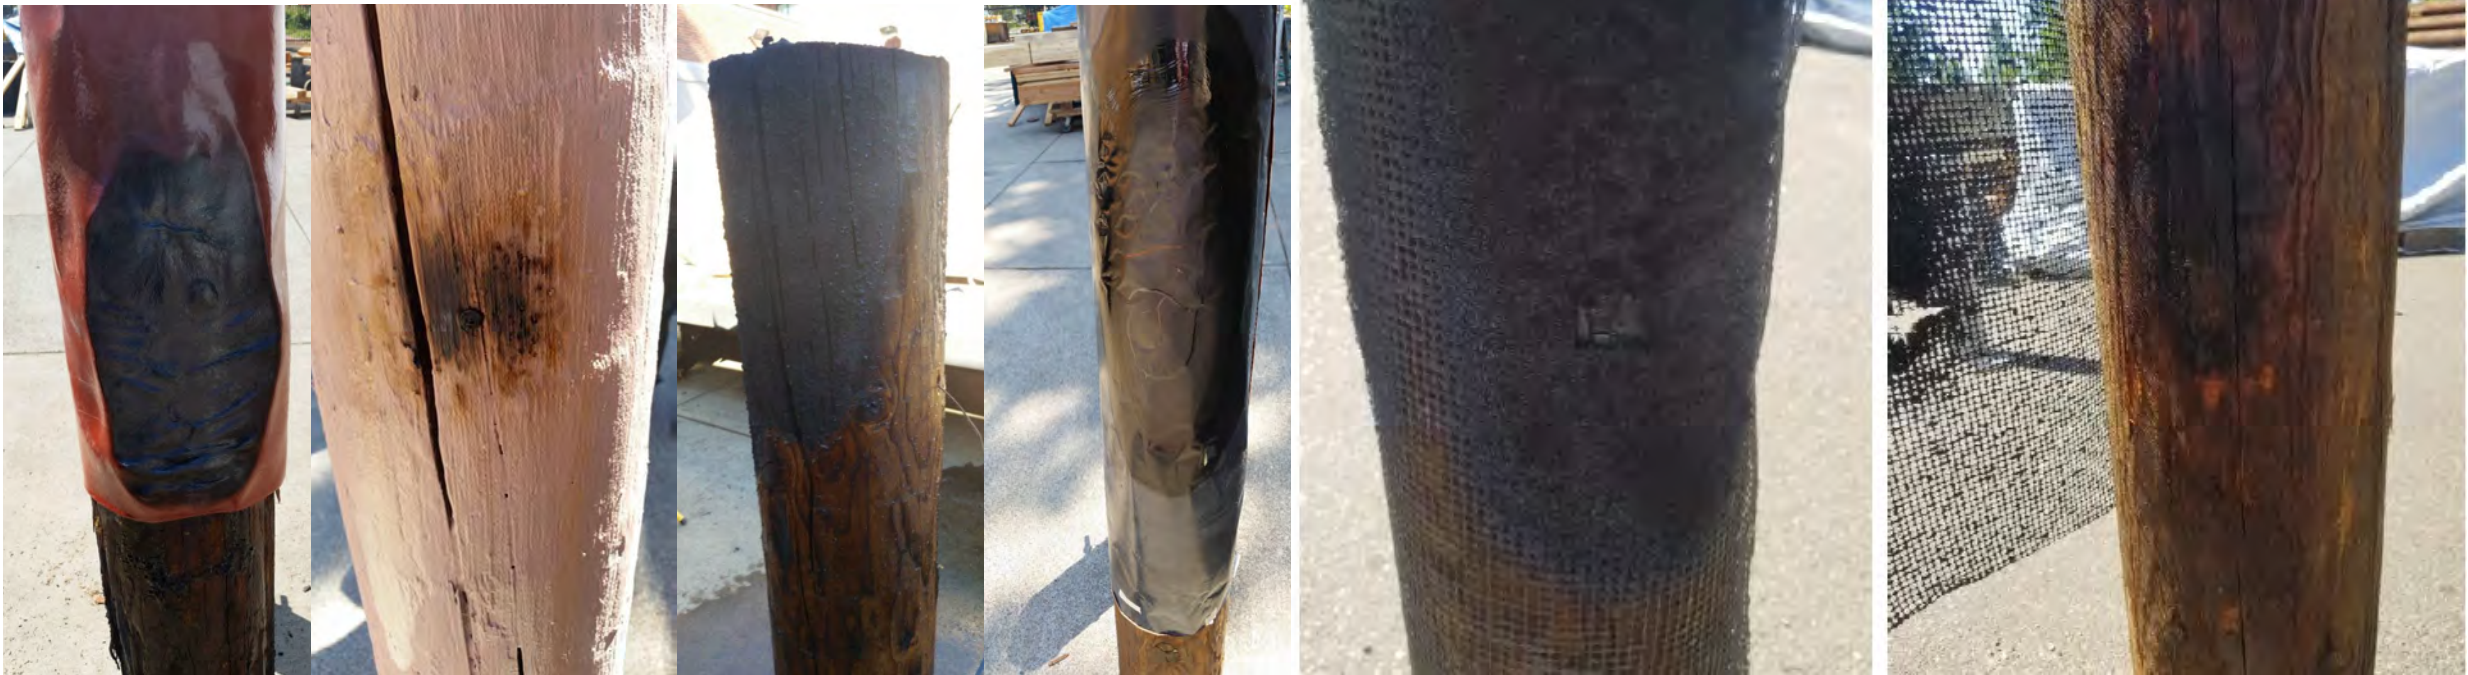
Rapid Testing of New Commercial Products

- Previous work by Konkler and Morrell compared barriers and coatings

Brooks
Polyurea
Barriers

FireGuard
Coating

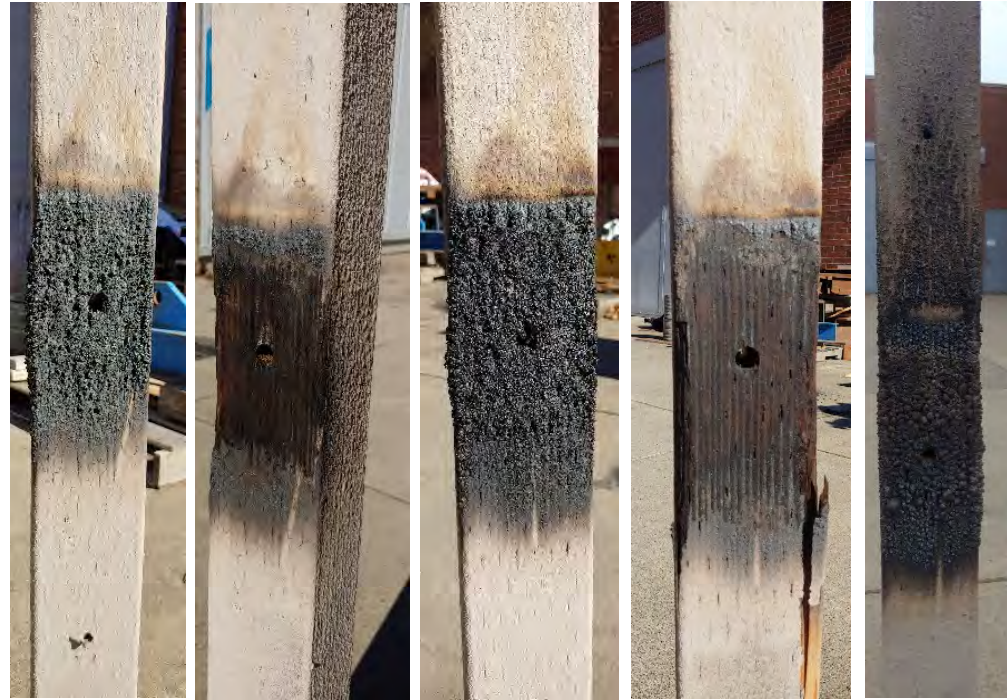
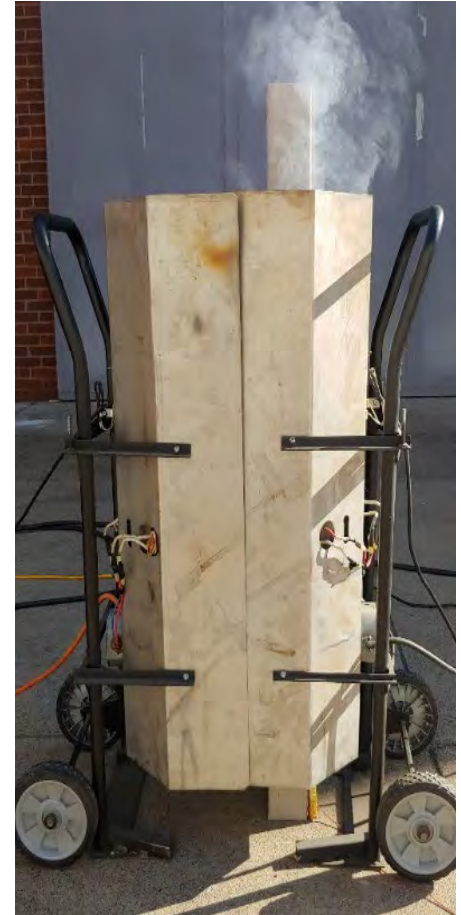
Adaptation for Crossarm Testing

- Fire retardant-treated crossarms: Fire Protection Coating
- Titanium Dioxide coating

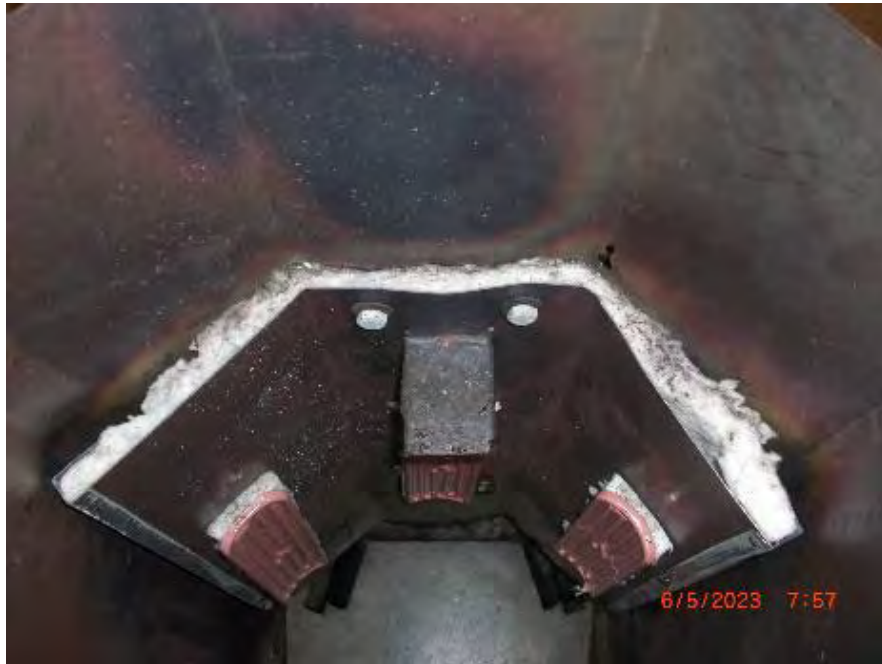
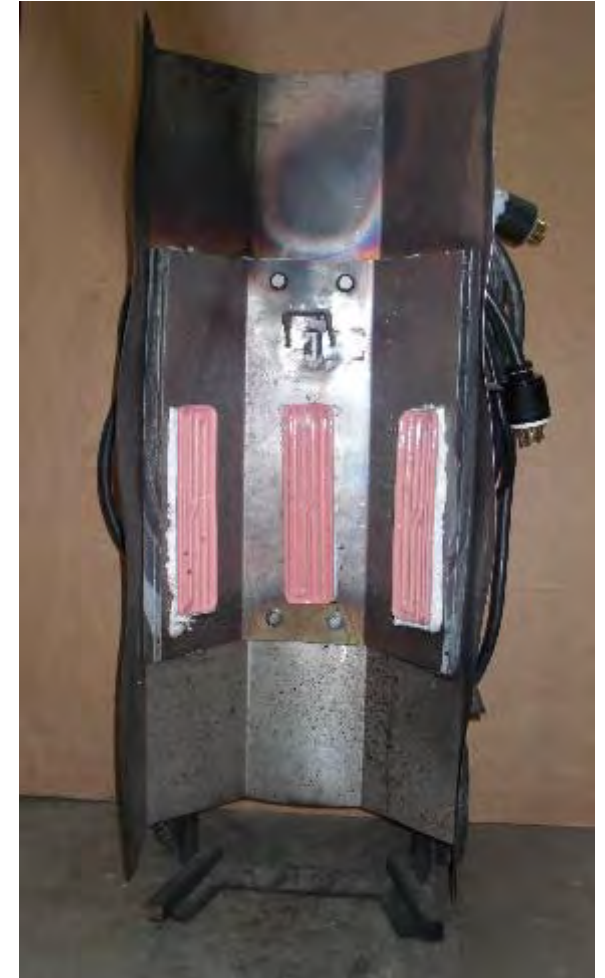
Improvements for Apparatus Durability

- Insulation, spacing, and wiring improved system durability
- Proven performance in over 40+ consecutive burns in one week
- Plans for write up into standard protocol
